Project Name: Caldwell Street Elevated Storage Tank Rehabilitation Zip Code: 43406

**VILLAGE OF BRADNER  
CALDWELL STREET ELEVATED STORAGE TANK REHABILITATION  
PROJECT NARRATIVE**

On April 10, 2018 Dixon Engineering Inc. performed a maintenance inspection on the 150,000 gallon sphere elevated water storage tank owned by the Village of Bradner, Ohio. Purposes of the inspection were to evaluate the interior and exterior coating's performance and life expectancy, assess the condition of metal surfaces and appurtenances, review safety and health aspects, and make budgetary recommendations for continued maintenance of the tank. All recommendations with budgeting estimates for repairs are incorporated in this report. The inspection was performed by Kyle Lay, Engineering Technician. The inspector was assisted by Dustin Houghton, Trevor Jessup, and Larry Houck, Staff Technicians. Following the inspection, chlorine was added to disinfect the tank per AWWA Standard C652-11 Method No. 3.

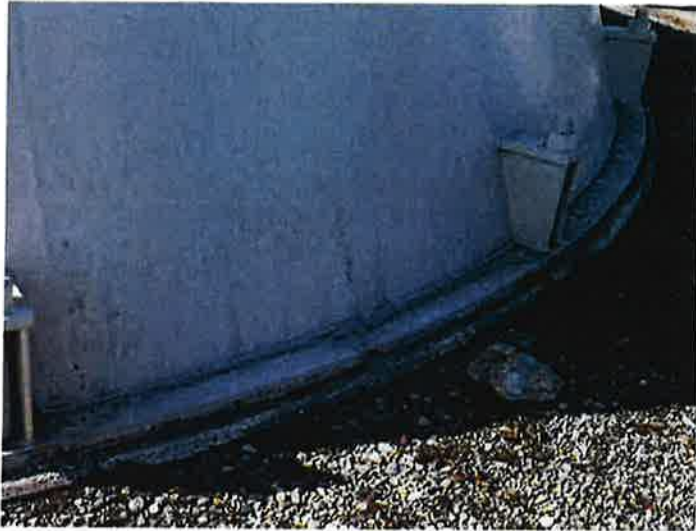
1) The exposed foundation is in good condition with no significant failures.

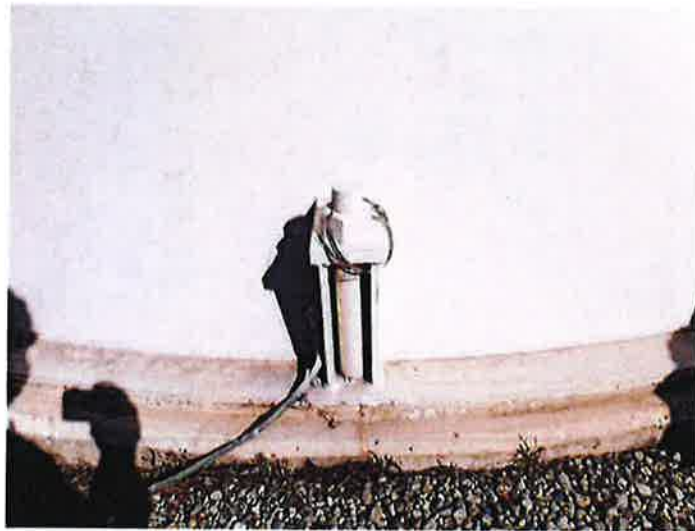
2) Typical anchor bolt coating is in good condition.

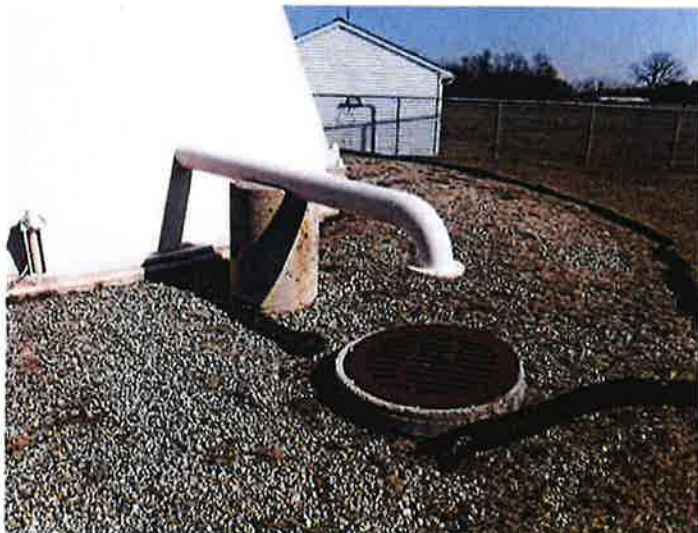
3) The overflow pipe discharge area is in good condition.

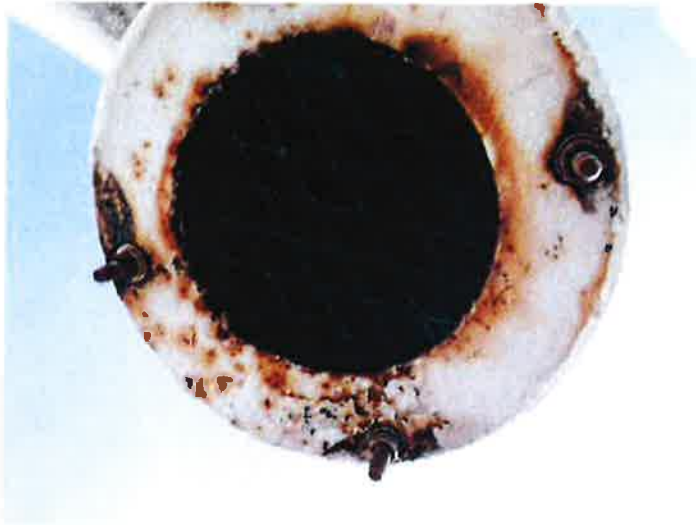
4) The overflow pipe screen is in good condition.

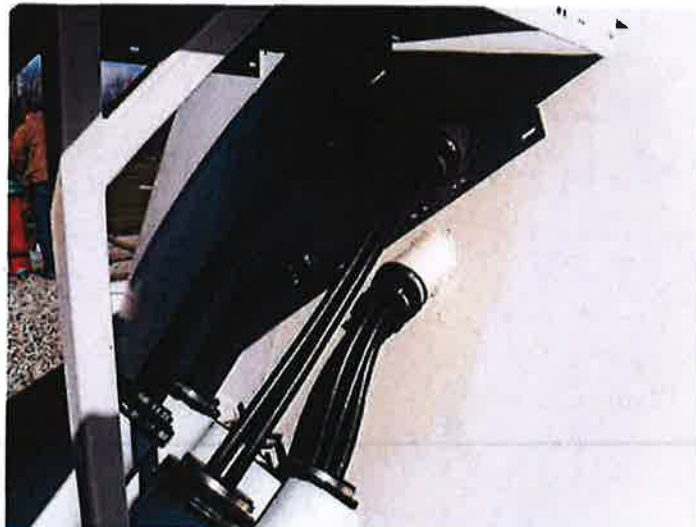
5) The antenna cable penetrations in the basebell are sealed with rubber boots.

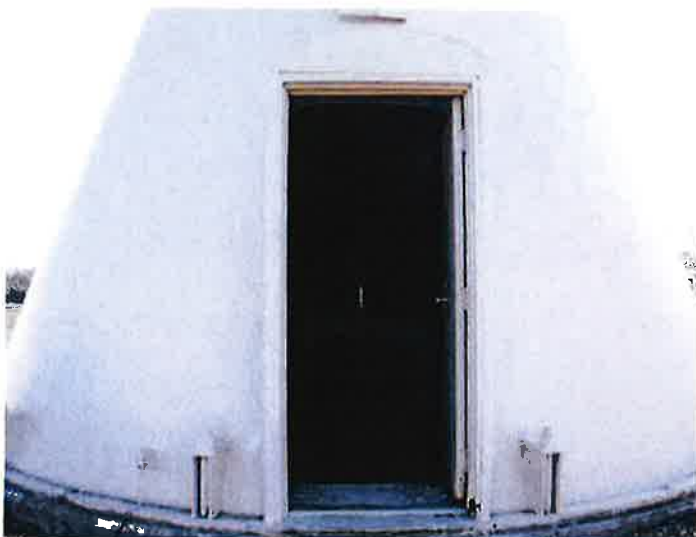
6) The access door operated properly during inspection.

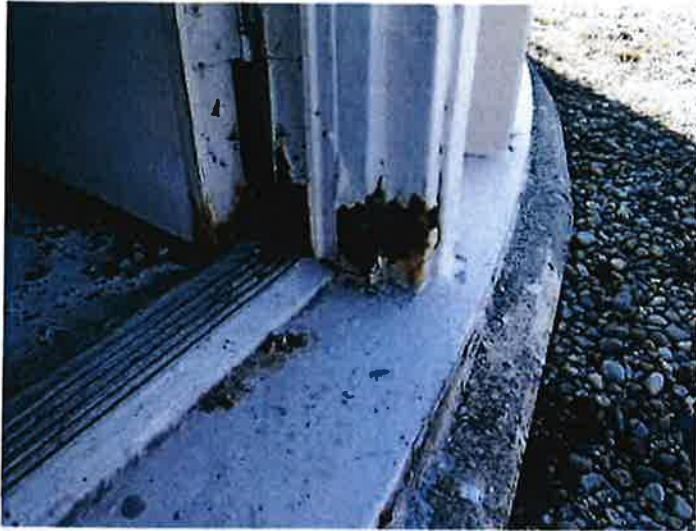
7) There is deterioration on the lower section of the door frame.

9. Replace the basebell door frame. The estimated cost is \$2,000.
10. Install a ladder extension at the condensate platform and a handhold at the wet interior roof hatch and access tube roof hatch to assist entering and exiting. Cost would be incidental to the next coating project.

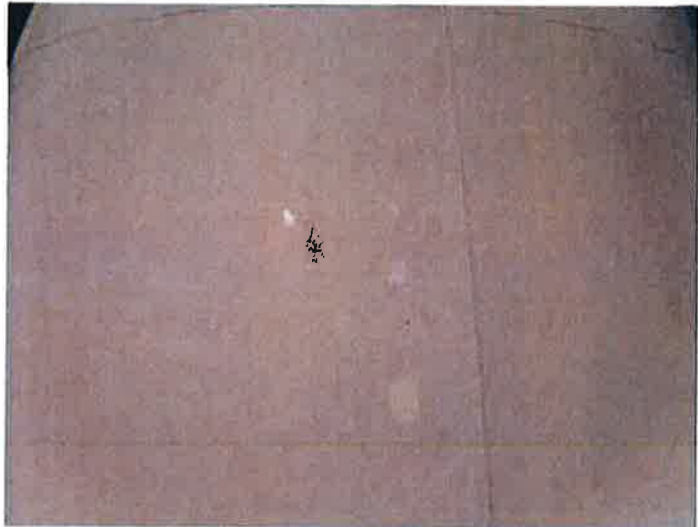
The basebell coating is in good condition with a few small spot failures. Primary methods of deterioration are spot failures to the substrate and rock nicks.

8) Minor coating failures on the basebell.

The recommended procedure is to high pressure water clean (5,000-10,000 psi) the exterior to remove any delamination or flaking coating and any contaminants. Then any coating failures would be spot power tool cleaned to bare metal (SSPC-SP11) condition with vacuum attachments.

The coating system would consist of a spot prime coat on the bare metal, a full coat of epoxy, and followed by two full coats of polyurethane. The polyurethane system offers excellent abrasion resistance with high gloss and sheen retention. The expected life of this system is fifteen years. The tank would be removed from service during the coating project. This is necessary to reduce condensation on the tank's surface. Polyurethane coatings have a minimum temperature requirement for application and are sensitive to moisture during the curing process. If moisture is present during the curing process, the appearance will become cloudy with little or no gloss. The estimated cost to spot power tool clean and overcoat the existing system with an epoxy polyurethane system is \$50,000.

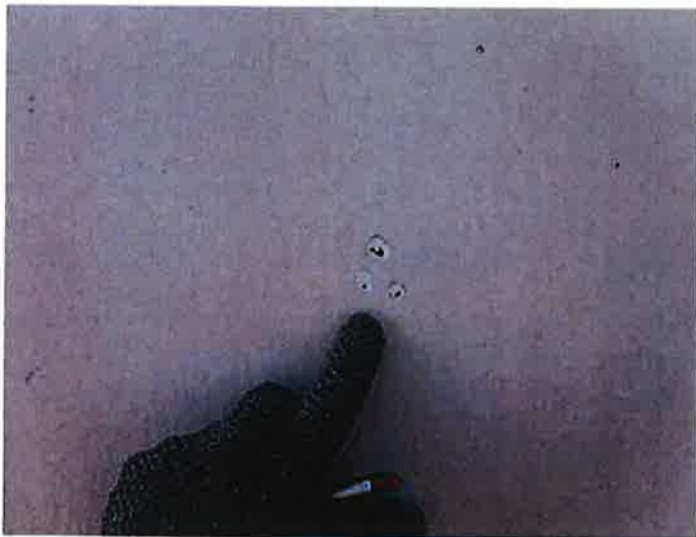
9) Rock nicks on the basebell.

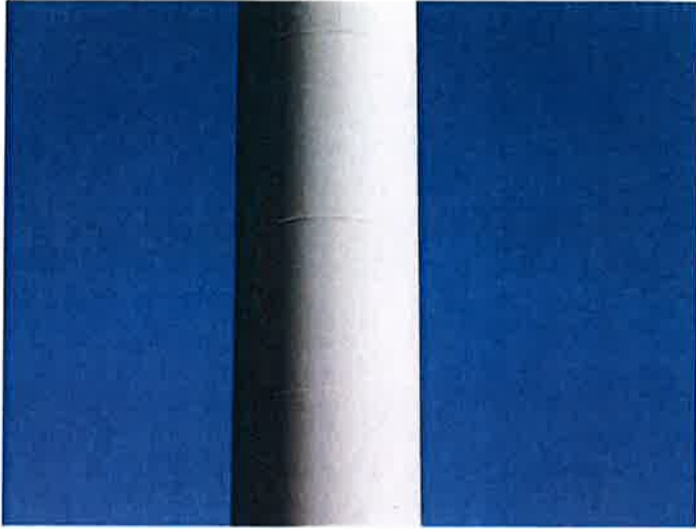
10) The riser coating is in good condition with minor fading.

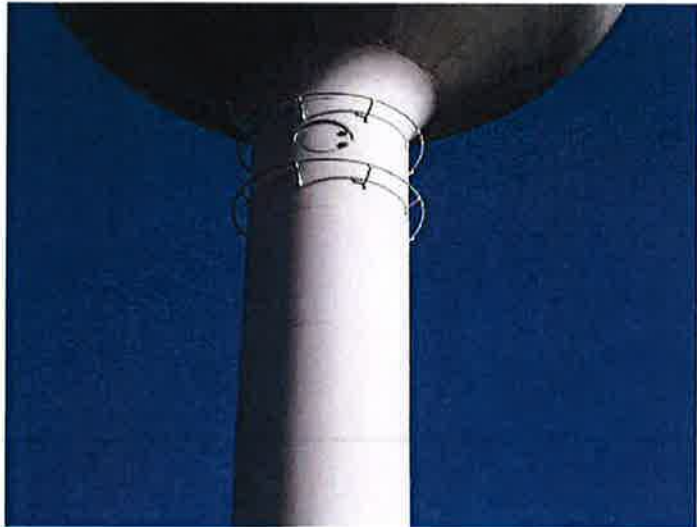
11) Same.

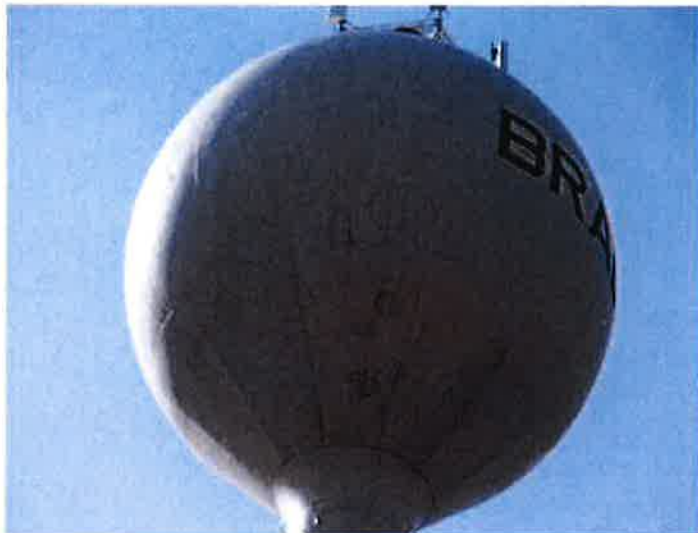
12) The bowl coating is in good condition with minor fading and previous touch-ups.

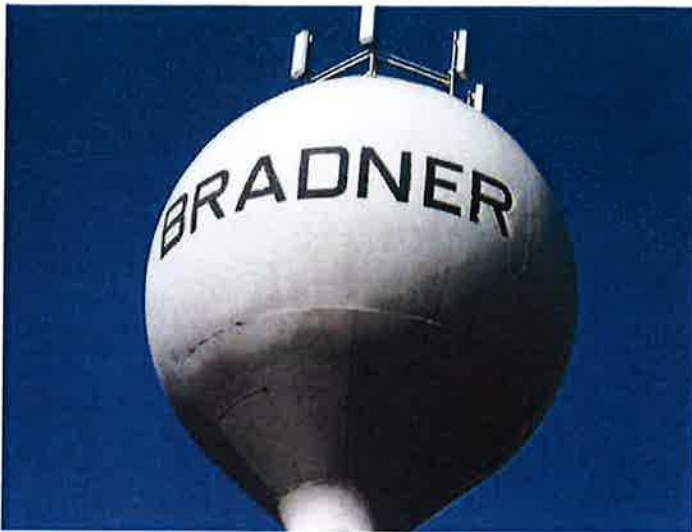
13) The sidewall coating is in good condition with minor fading.

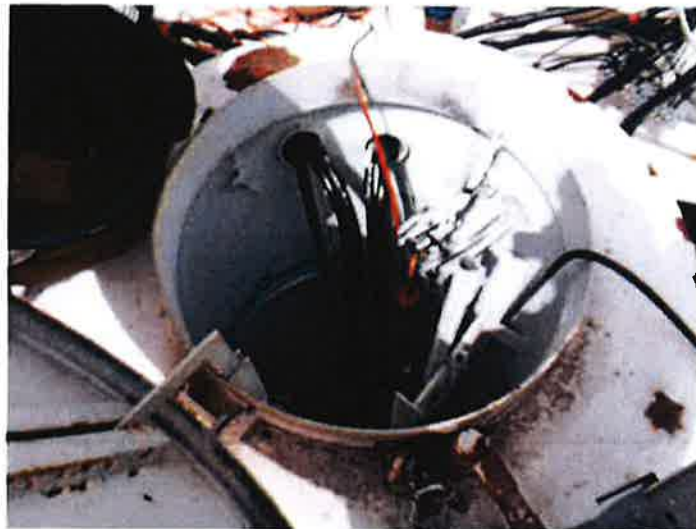
14) Access tube cover with hinged hatch.

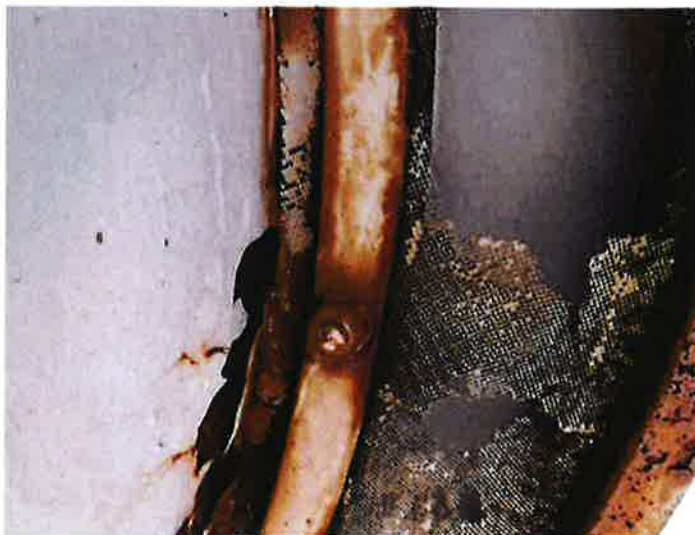
15) Significant deterioration of the access tube air gap screen.

11. Replace the roof vent with a new frost-free pressure vacuum vent. The estimated cost is \$6,000.
12. Install a neoprene cover over the access tube air gap to eliminate it as a point of possible contamination. Cost would be incidental to exterior recoating.

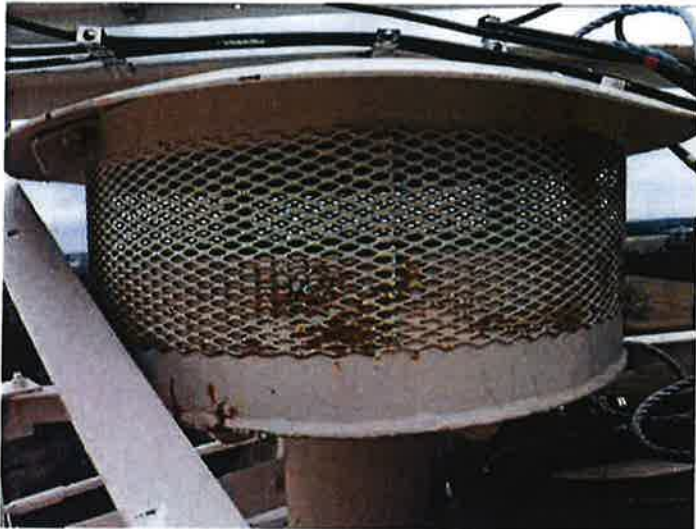
16) The pressure vacuum vent coating is in poor condition.

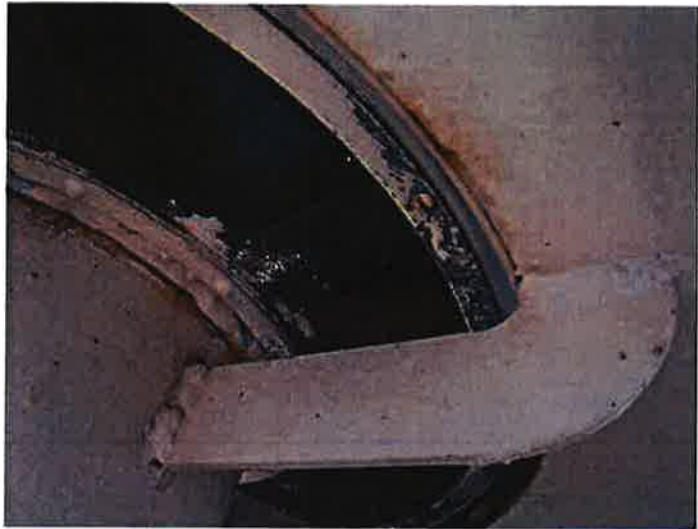
17) The vent screen is in poor condition with large gaps.

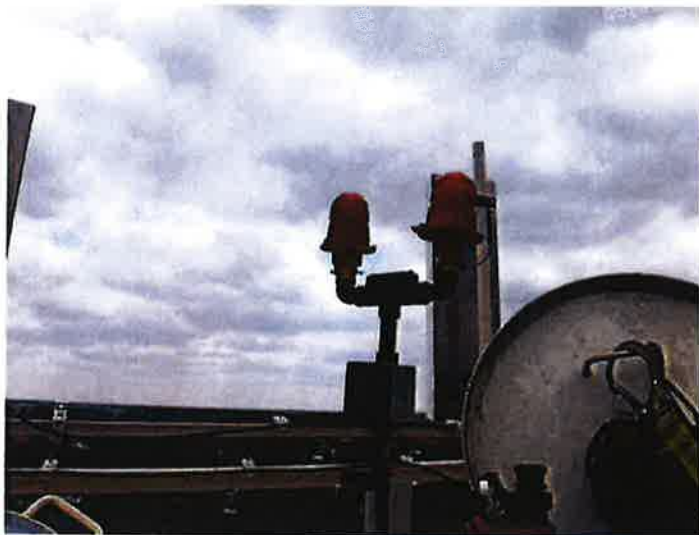
18) The aviation light is in good condition.

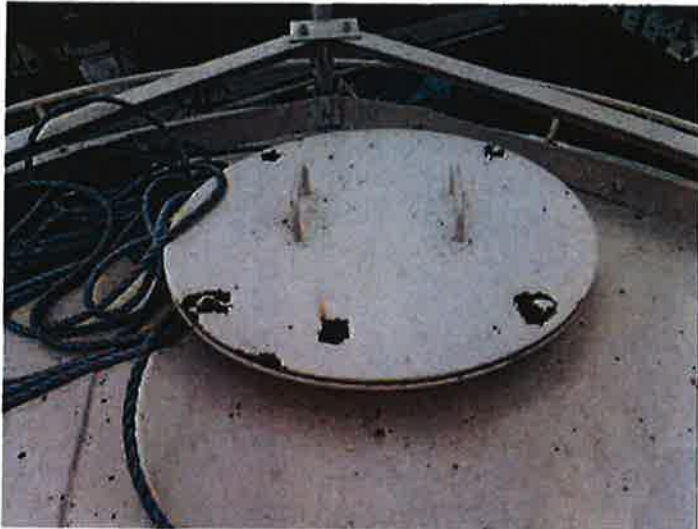
19) The roof contains a bolted ventilation hatch that is in good condition.

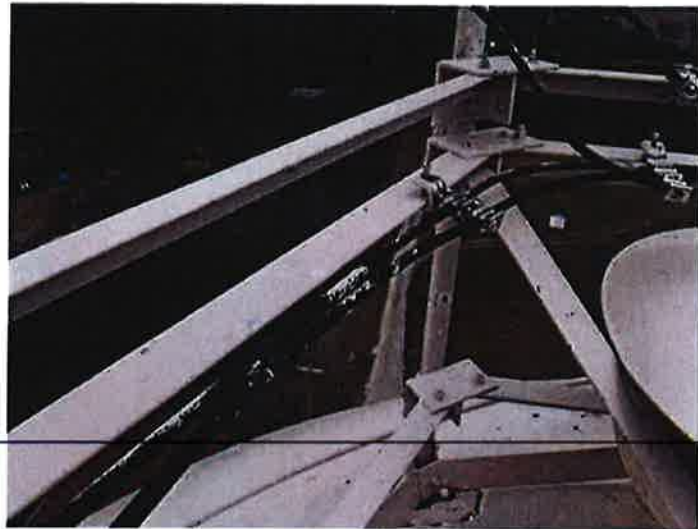
20) The roof handrail is in good condition. Antennas and cables are attached to the railing.

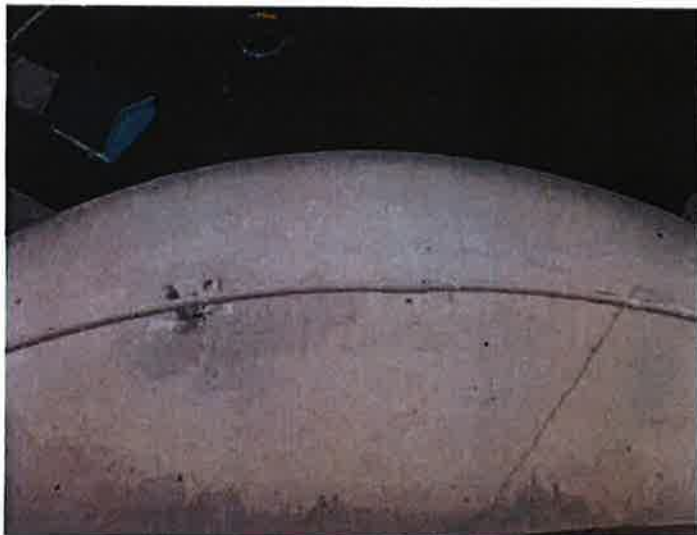
21) Roof painter's railing butt weld is not at stand-off.

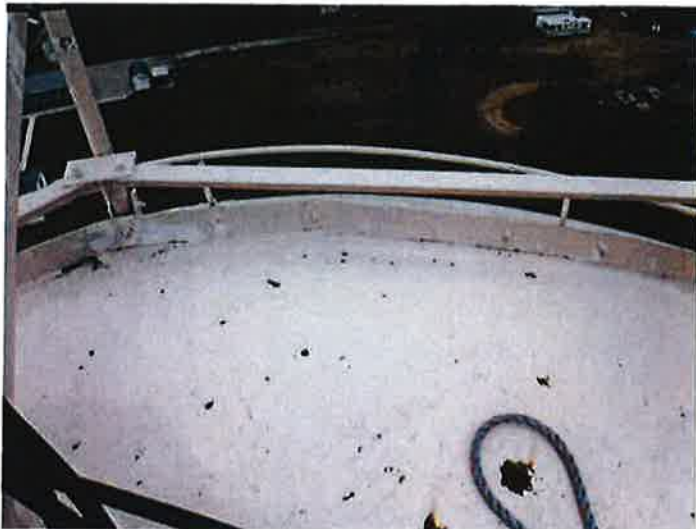
The roof coating is in fair condition with a few minor failures. Primary methods of deterioration are spot failures to the substrate with rust undercutting with most located inside the roof handrail.

22) The exterior roof coating is in fair condition with spot failures inside the railing.

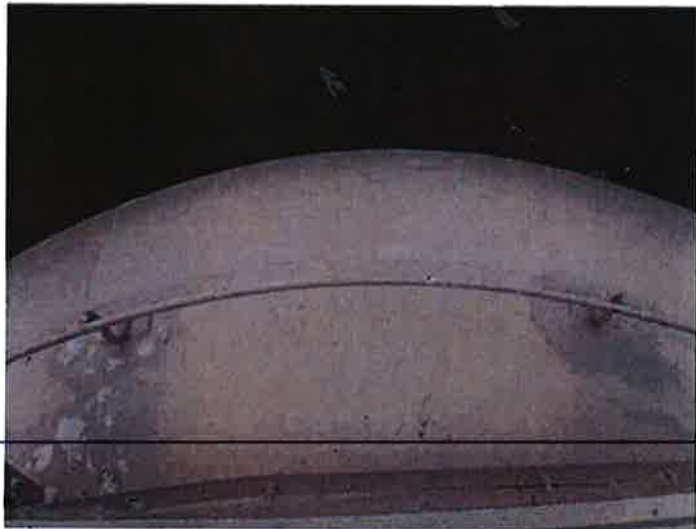
23) The exterior roof coating is in fair condition.

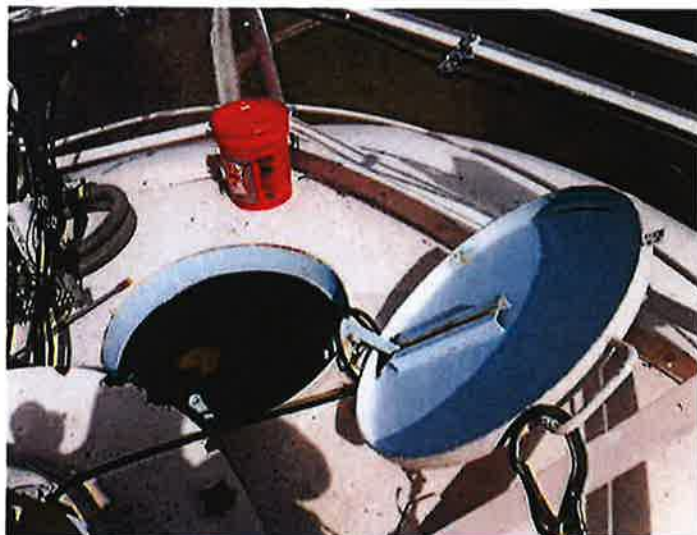
24) The exterior roof hatches are in good condition and operated properly during the inspection.

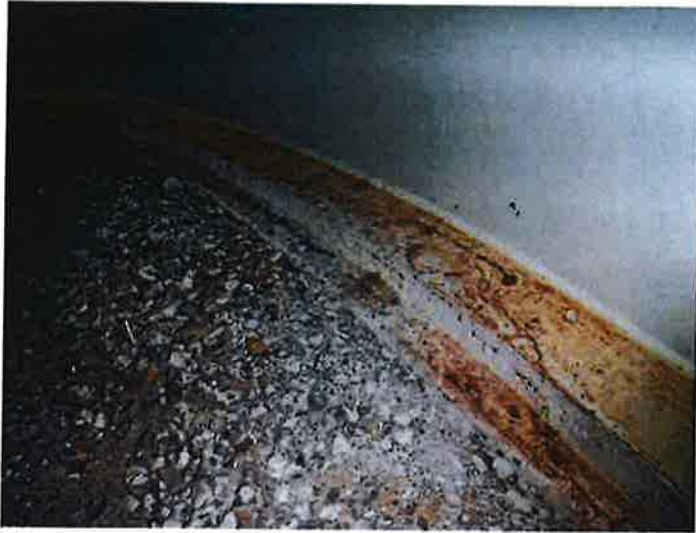
The basebell coating is in good condition with only a few minor failures. Primary methods of deterioration are spot failures to the substrate and rust bleedthrough on the baseplate.

25) Failures on the baseplate.

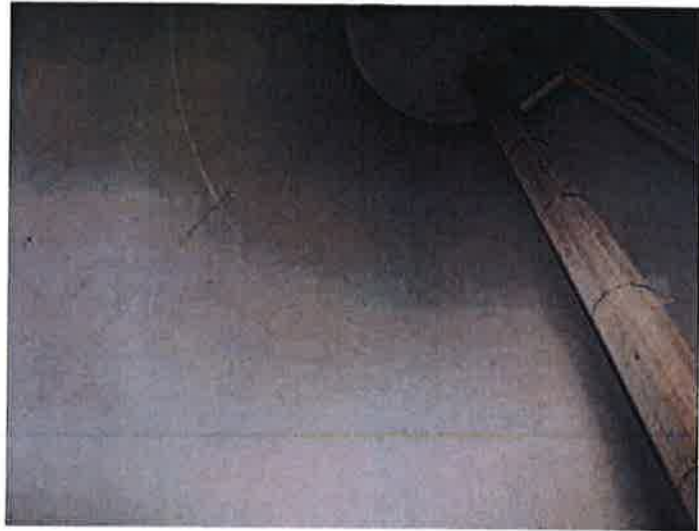
26) The basebell coating is in good condition.

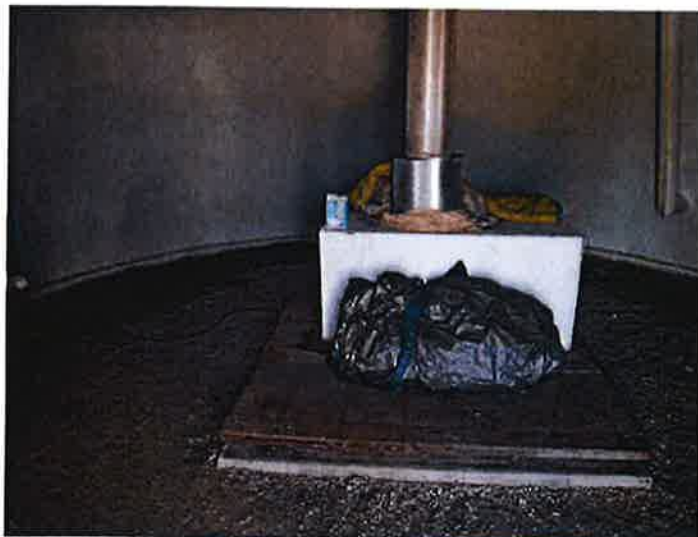
27) The pit piping cover is in good condition.

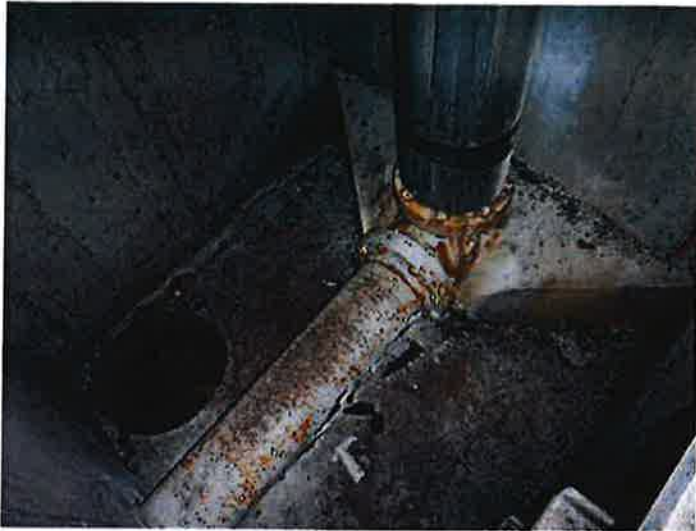
28) The coating on the pit piping is in poor condition.

4. Abrasive blast clean the pit piping to a commercial (SSPC-SP6) condition and apply an epoxy system. The estimated cost is \$3,000.
5. Recoat the foundation to help prevent deterioration. Cost would be incidental to exterior coating.

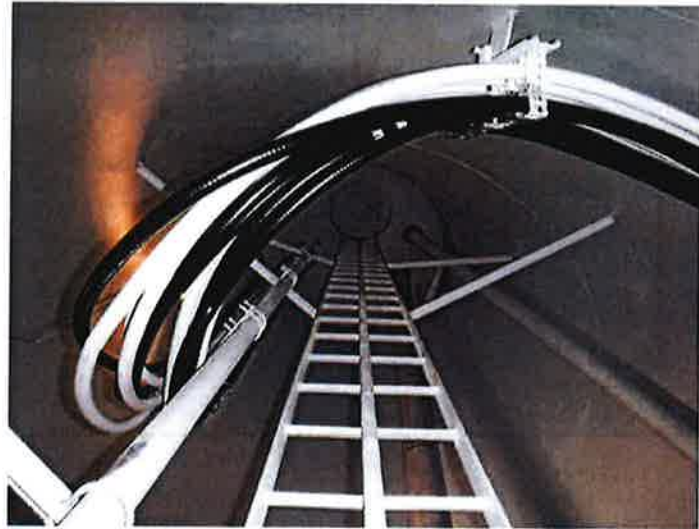
29) The basebell ladder is in good condition and is equipped with a fall prevention device.

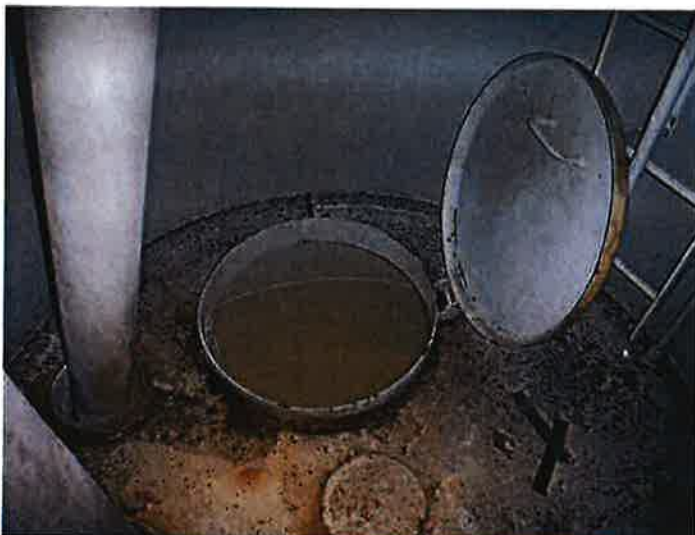
The coating on the top of the platforms is in fair to poor condition with numerous failures. Primary methods of deterioration are spot failures to the substrate with rust undercutting and delaminated topcoat.

30) Condensate platform opening with hinged cover and handhold. The coating is in poor condition with spot failures to the substrate.

Spot abrasive blast clean to a commercial (SSPC-SP6) condition the topside of the platforms including one foot up the riser walls and the other areas of failed coating. The bare metal would be coated with an epoxy system. The estimated cost of spot recoating is \$15,000.

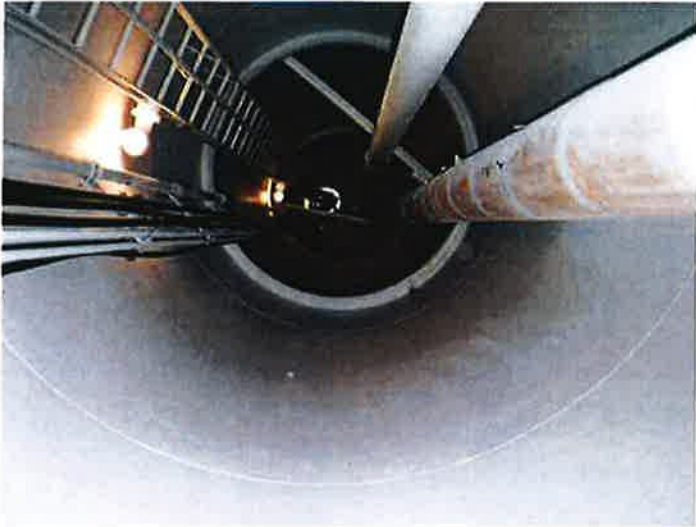
31) The riser coating is in good condition.

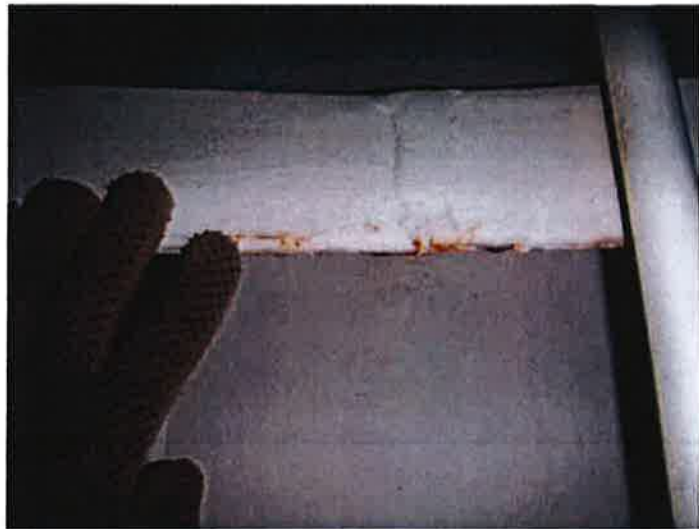
The riser coating is in good condition with only a few failures. Primary methods of deterioration are spot failures to the substrate and rust bleedthrough on the stiffeners.

32) Failures on a riser stiffener.

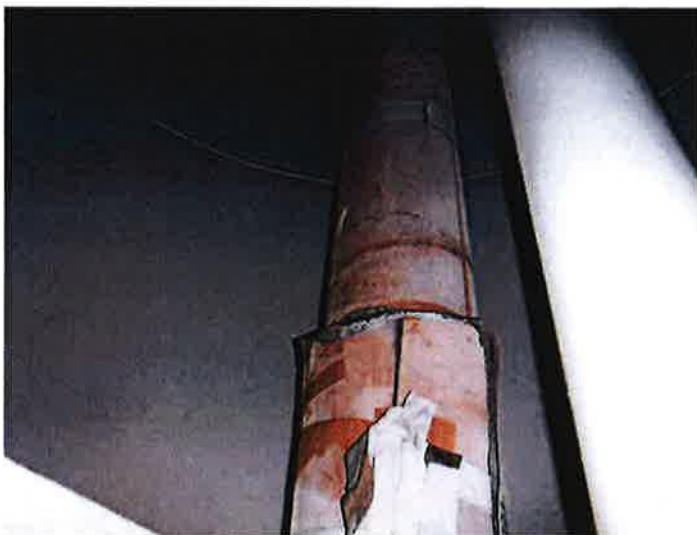
33) The insulation over the fill pipe is in fair condition overall.

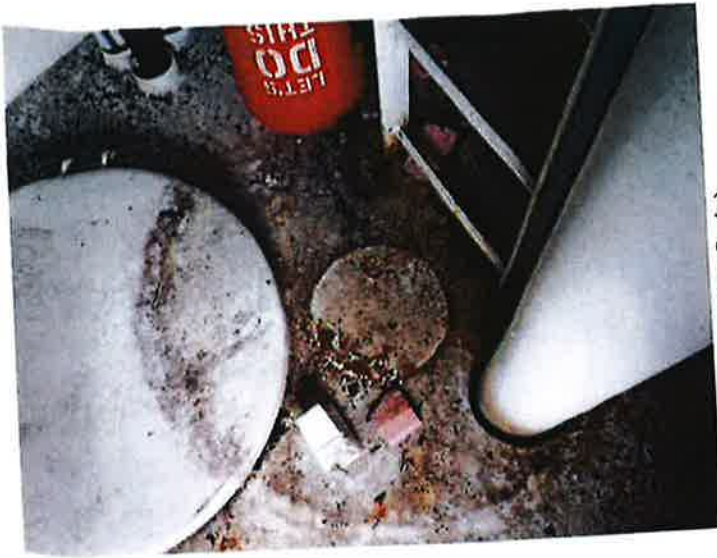
34) Top platform opening with cover. There are spot coating failures in the center of the platform.

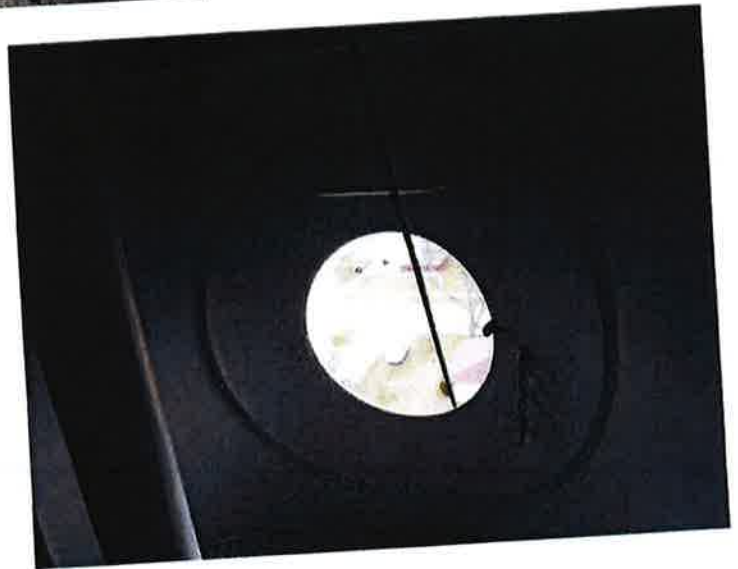
35) The painter's hatch is in good condition and operated properly during inspection.

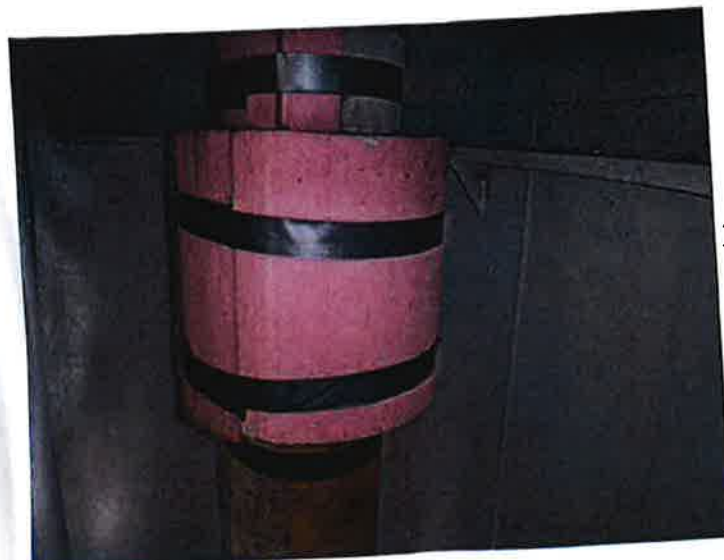
36) The expansion joint is covered with insulation and was not visible for inspection.

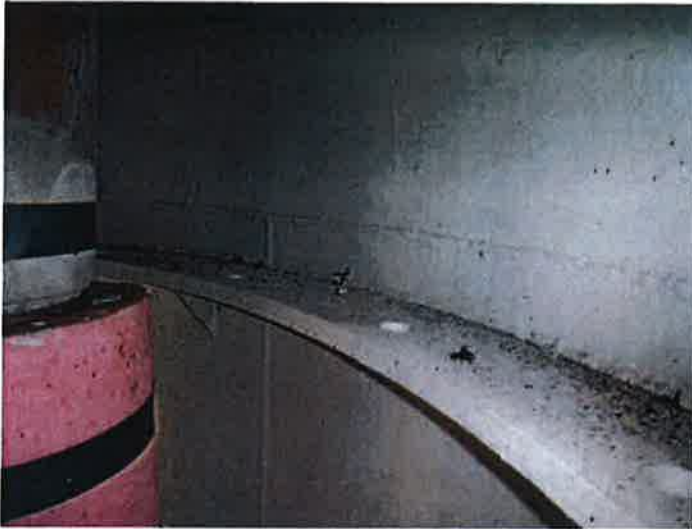
37) The coating above the top platform is in good condition.

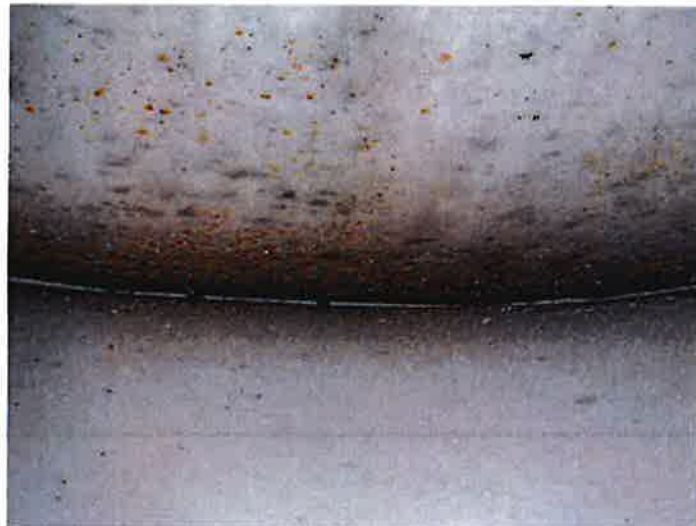
The bowl coating is in good condition with rust bleedthrough at the riser transition.

38) Rust bleedthrough on the bowl.

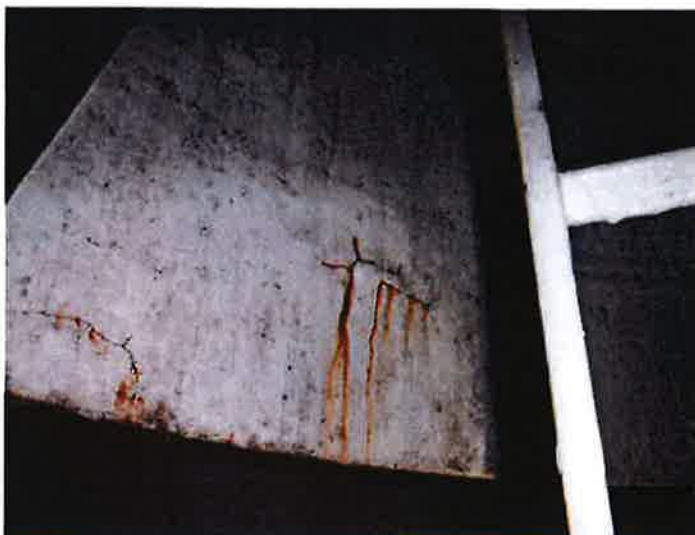
The access tube coating is in fair condition with several failures. Primary methods of deterioration are spot failures to the substrate with rust undercutting. Most of the coating failures are on the bottom half.

39) Coating failure on the access tube.

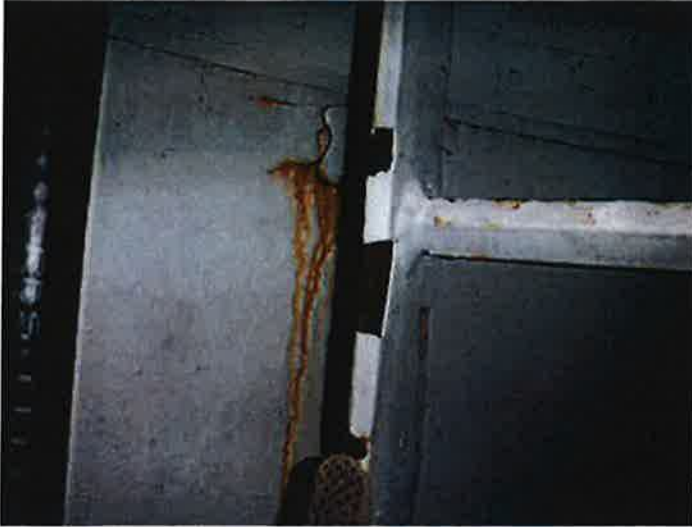
40) Same.

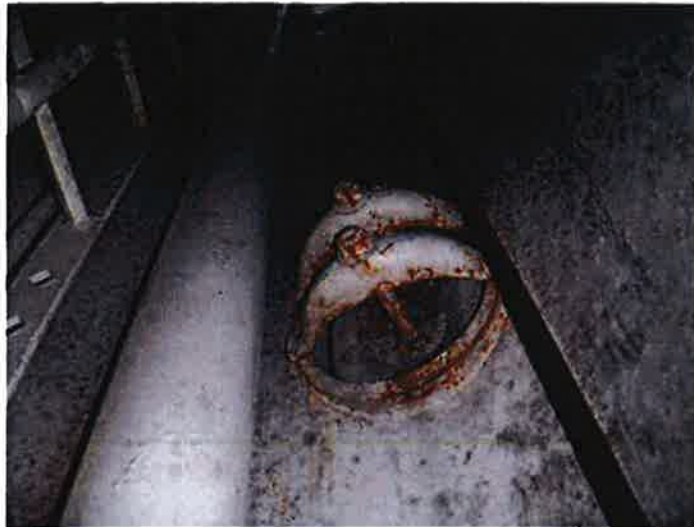
41) The access tube manway is in good condition. The coating is in poor condition.

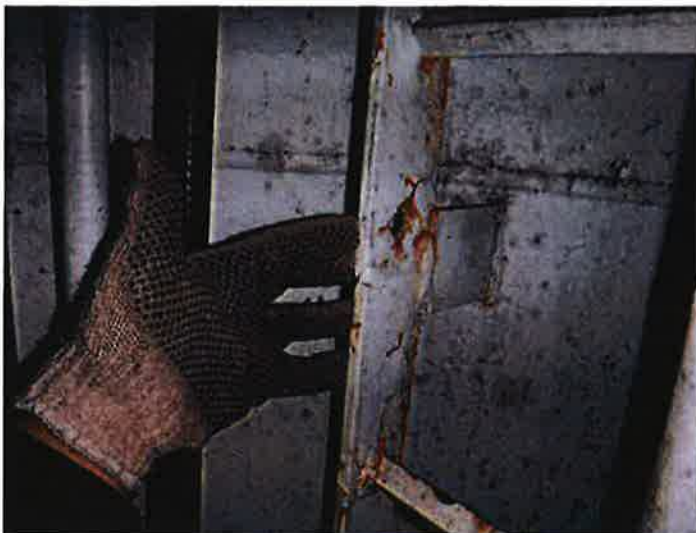
42) Coating failures on the access tube ladder.

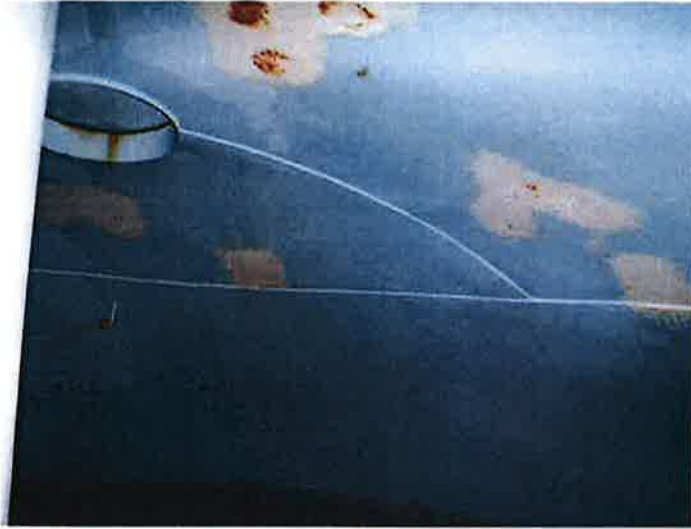
43) The wet interior roof coating is in fair condition with failures at previous spot repairs.

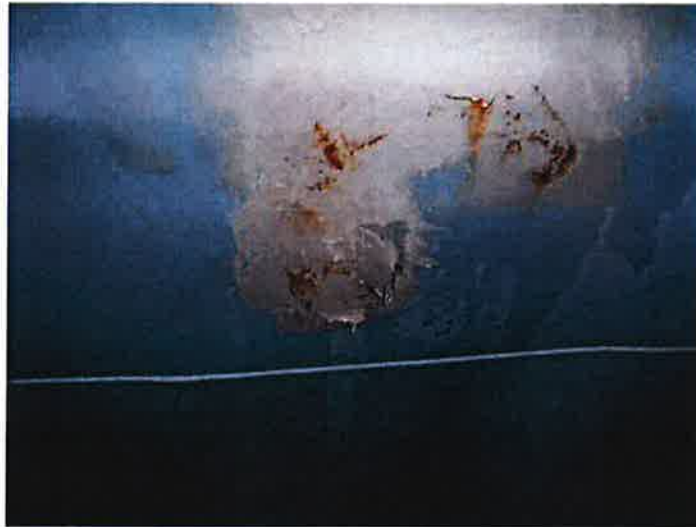
44) Same.

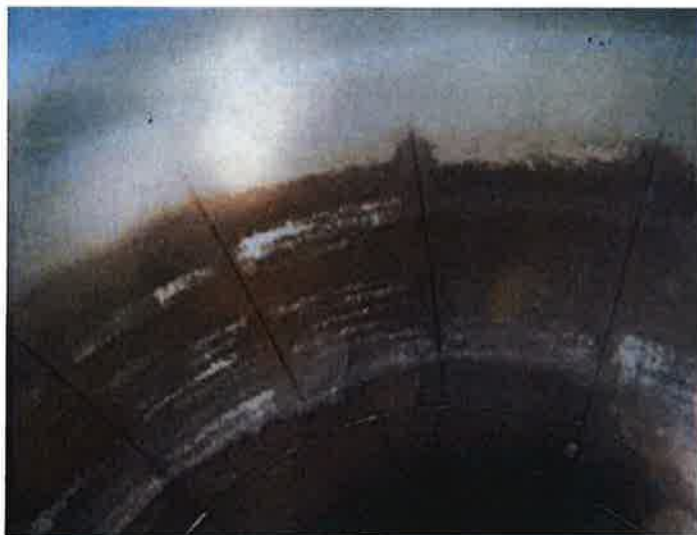
45) The sidewall coating is in good condition with no significant failures.

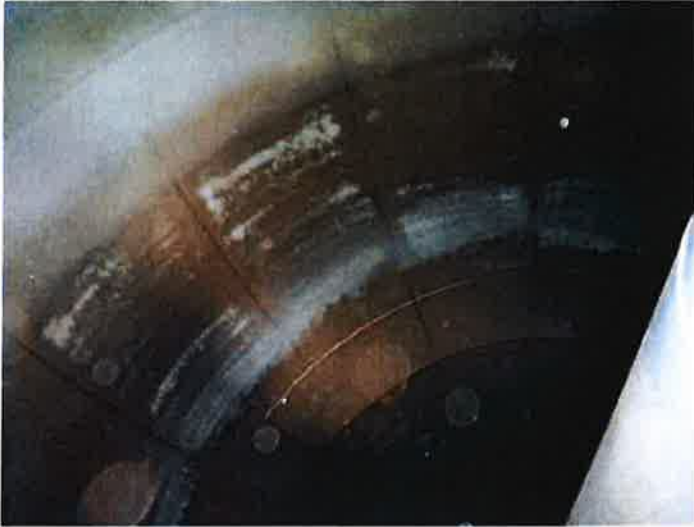
46) Same.

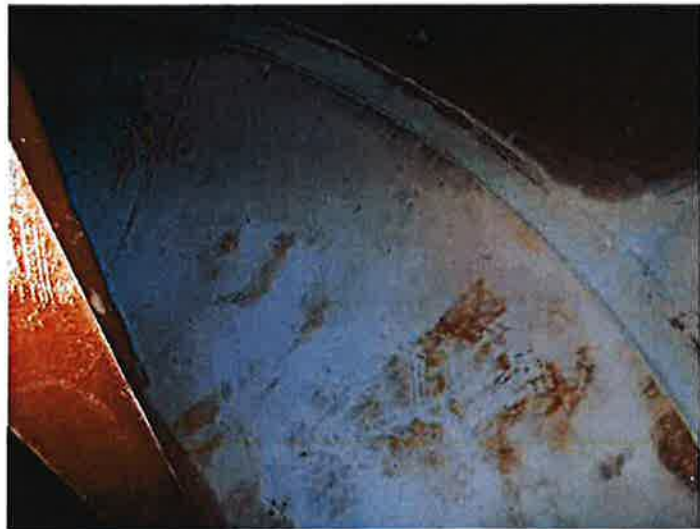
47) The bowl coating is in good condition with no significant failures.

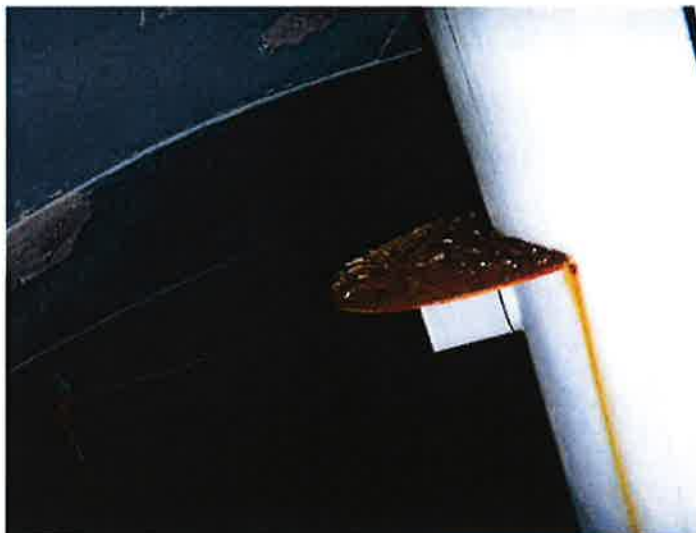
48) The overflow vortex break is in good condition.

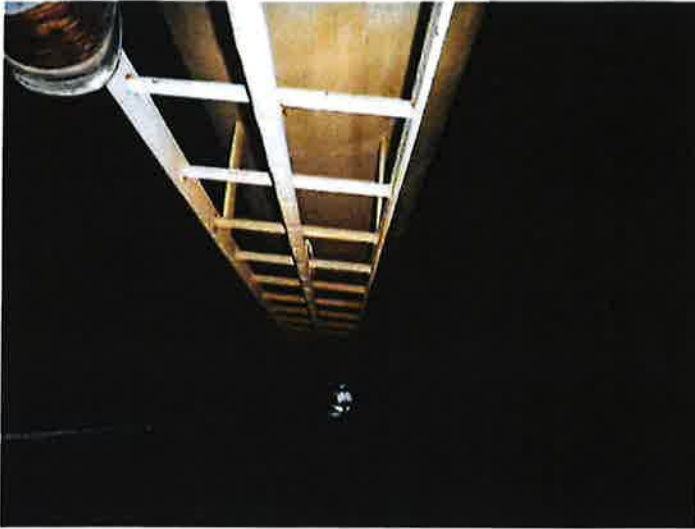
49) The wet interior ladder is in good condition and is equipped with a fall prevention device that operated properly during inspection.

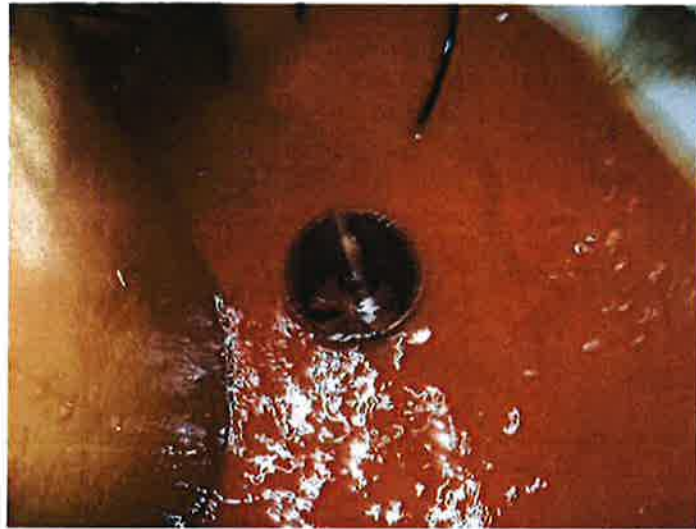
50) The bowl prior to cleaning.

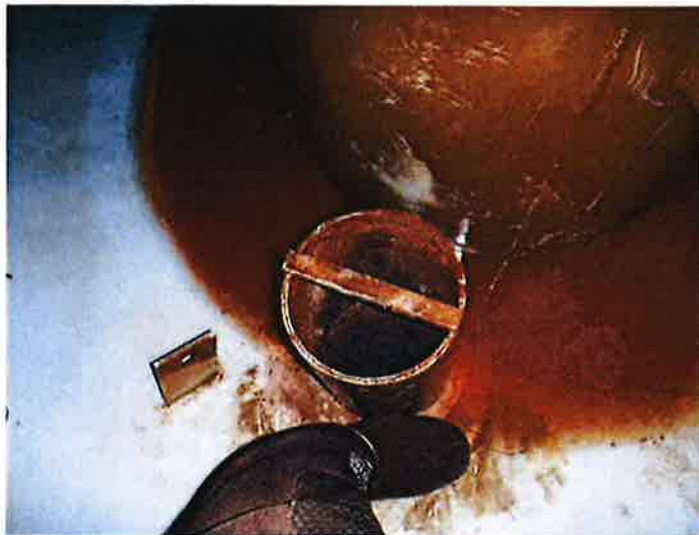
51) The fill pipe is in good condition.
