State of Ohio  
**Public Works Commission**  
*Application for Financial Assistance*

Project Name: Bloomdale Elevated Tank Painting and Repairs Zip Code: 44817

## **Bloomdale Elevated Tank Painting and Repairs**

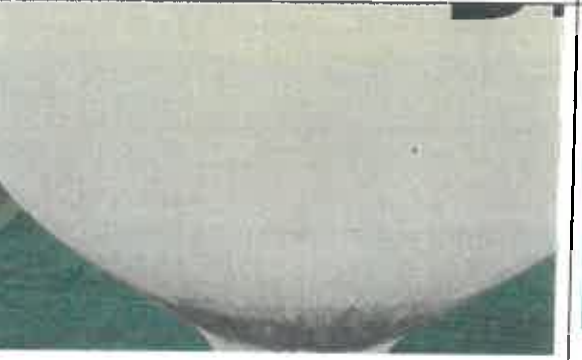
<p>Small coating break on lower equator</p>	<p>Coating break on pedestal</p>

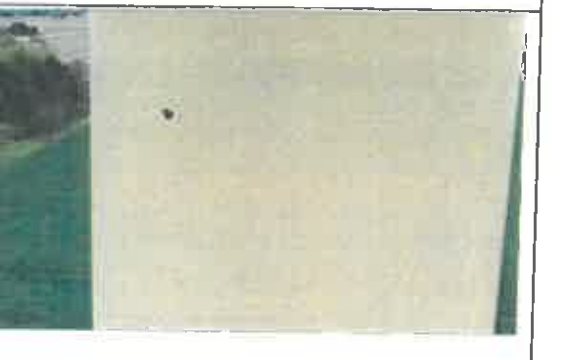
The coating remains over 99.99 percent intact along the pedestal. Minor signs of delamination and lifting were observed along the baseplates. The basebell appears to have been recoated to cover breaks in the original coating system. The polyurethane coating remains 99.999 percent intact along the bowl and equator with minor evidence of corrosion where the substrate is exposed. The roof, also, remains over 99.99 percent intact. The topcoat is showing signs of heavy weathering. A few minor signs of lifting from the substrate were seen. Small areas of intercoat delamination were observed. Surface corrosion has formed where the substrate was exposed.

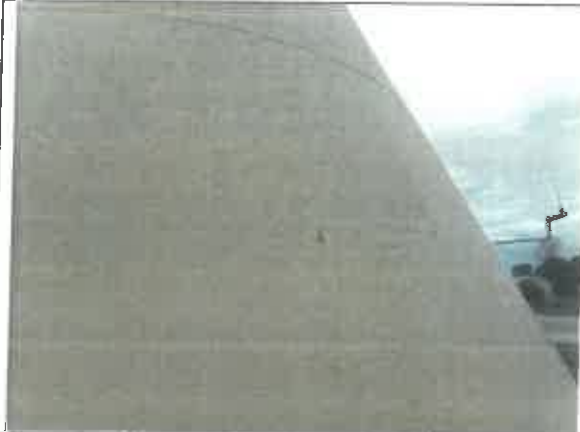
<p><b>Coating break on basebell</b></p>	<p><b>Overflow pipe with flap gate</b></p>

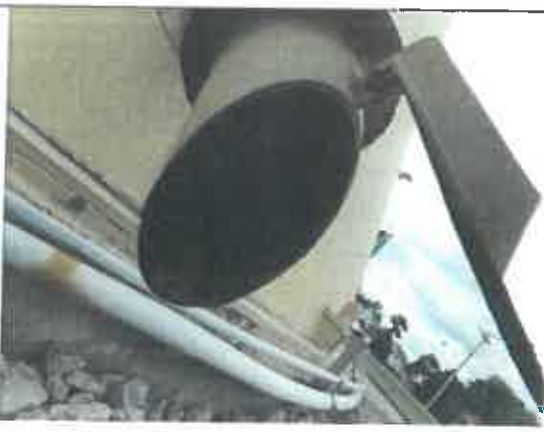
The appurtenances include overflow pipe, vent and hatches. The overflow pipe and support bracing are located within the dry interior. The base of the pipe extends through the basebell. There was no evidence of significant external corrosion. The base of the overflow pipe has a flap gate to prevent contamination; however, it does not contain a screen.

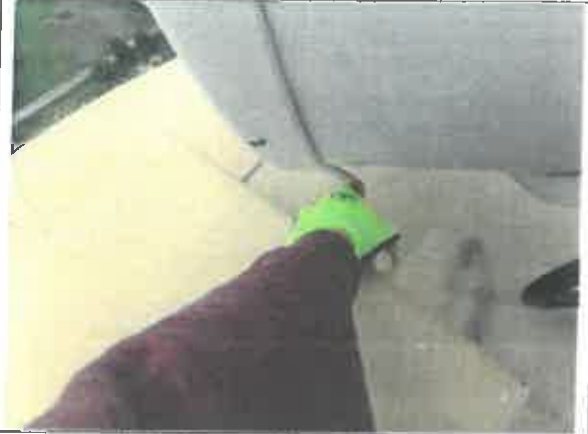
<p><b>Wet interior roof hatch blocked by antenna</b></p>	<p><b>Roof layout</b></p>

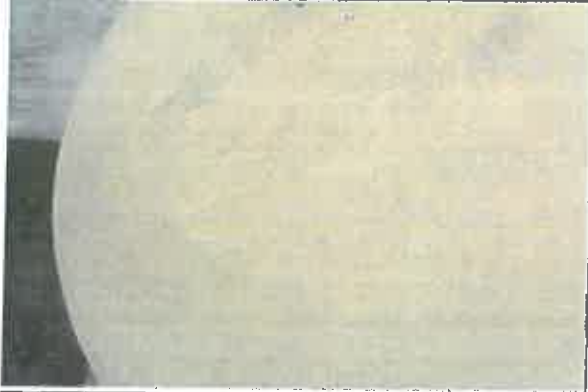
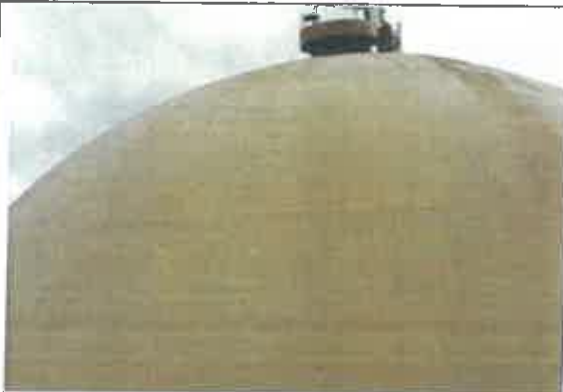
<p><b>Weathered coating on exterior roof</b></p>	<p><b>Weathered coating on exterior roof</b></p>
