ASBESTOS ABATEMENT SCOPE OF WORK FOR THE FORMER EDON SCHOOL

309 WEST INDIANA STREET, EDON, OH

December 7, 2022

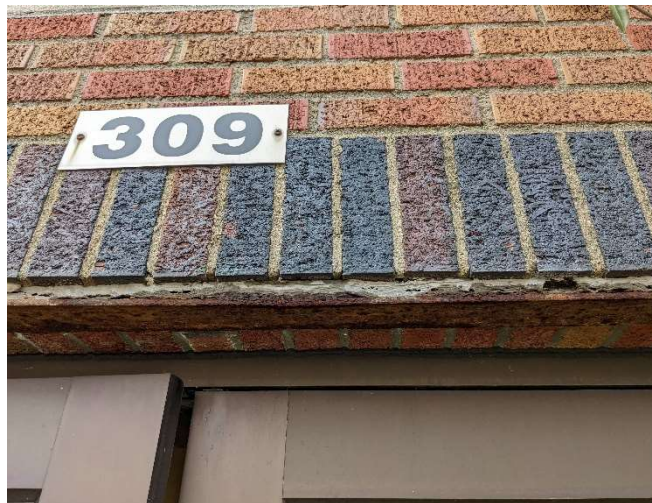
Positive asbestos sample ES-B1-EXC, window glazing behind exterior caulk on Building 1.

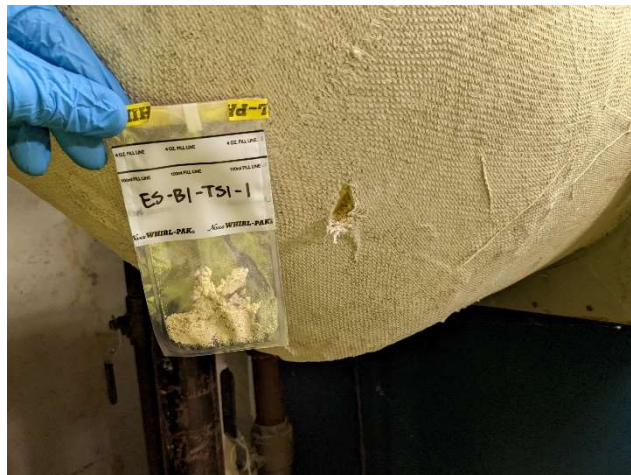
Positive asbestos sample ES-B1-TSI-1, TSI within Building 1.

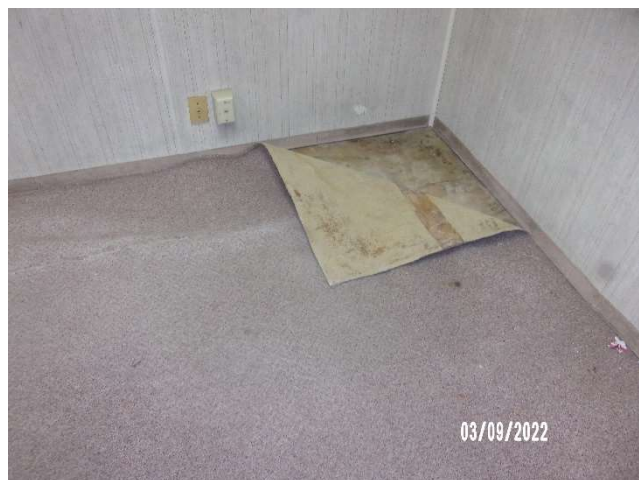
Positive asbestos sample ES-B1-CM6, carpet mastic within Building 1.

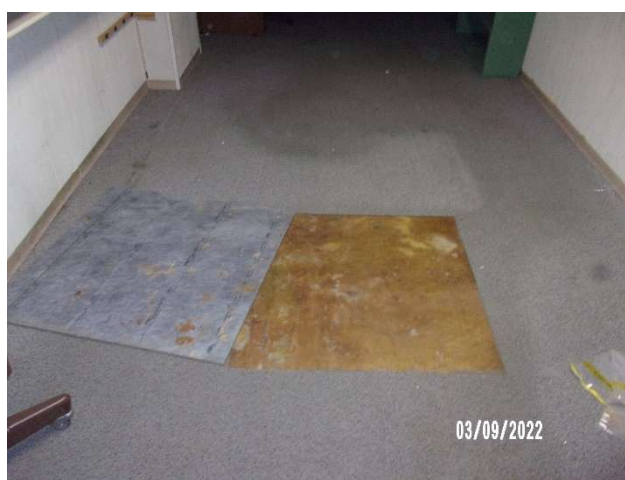
Positive asbestos sample ES-B1-CM7, carpet mastic within Building 1.

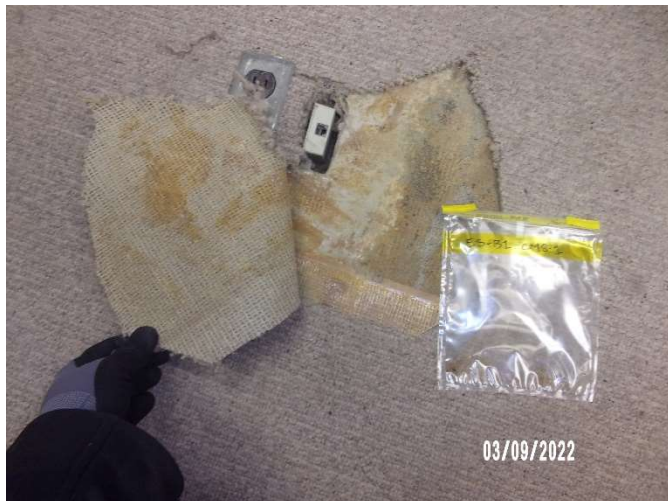
Positive asbestos sample ES-B1-CM8-1, carpet mastic within Building 1.

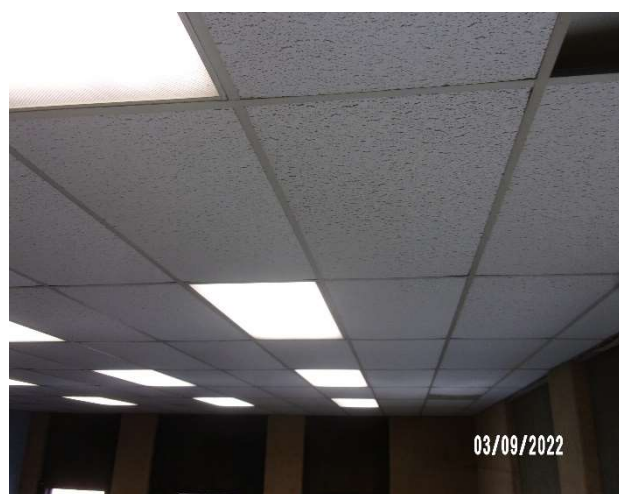
Positive asbestos sample ES-B1-CT1, ceiling tile within Building 1.

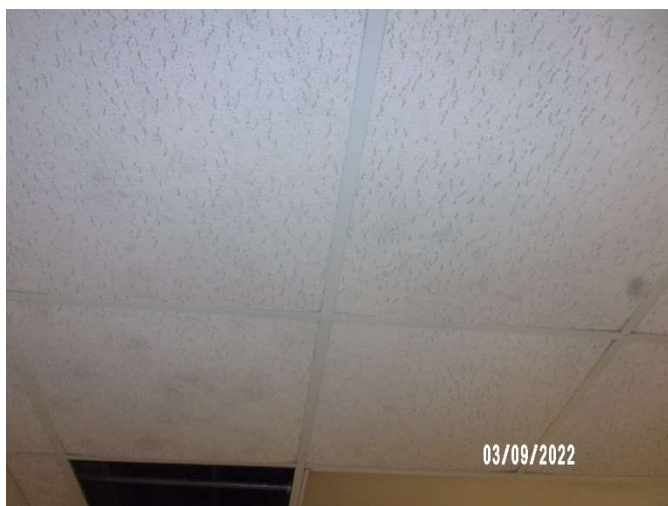
Positive asbestos sample ES-B1-CT6, ceiling tile within Building 1.

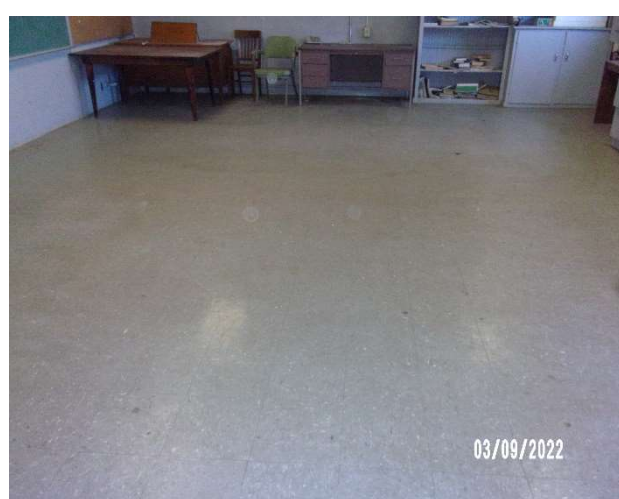
Positive asbestos sample ES-B1-FT6, mastic associated with show floor tile within Building 1.

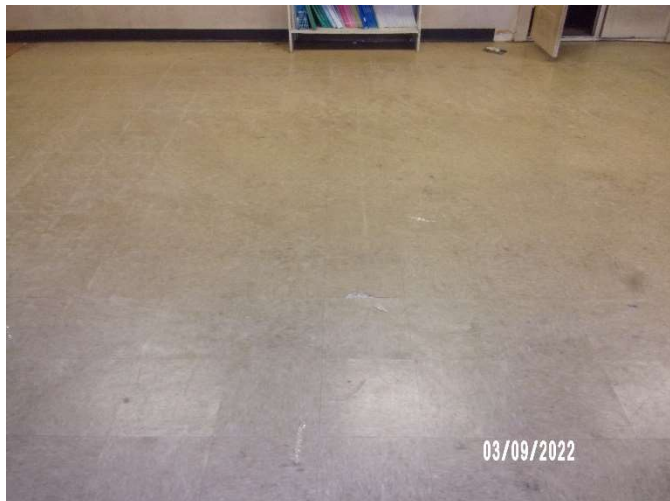
Positive asbestos sample ES-B1-FT7, mastic associated with shown floor tile within Building 1.

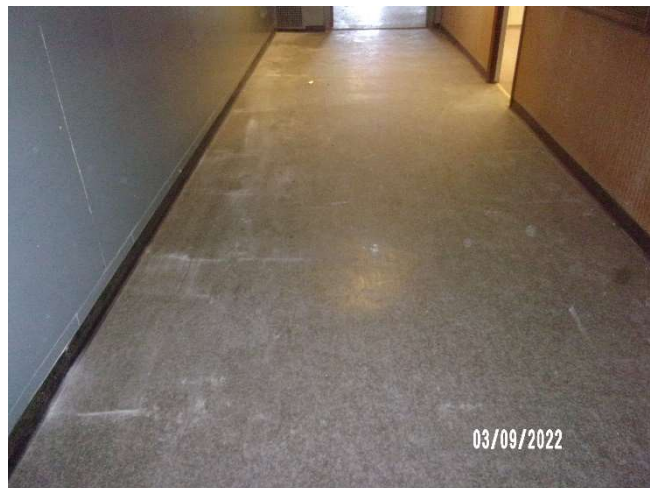
Positive asbestos sample ES-B1-FT8, linoleum floor tile within Building 1.

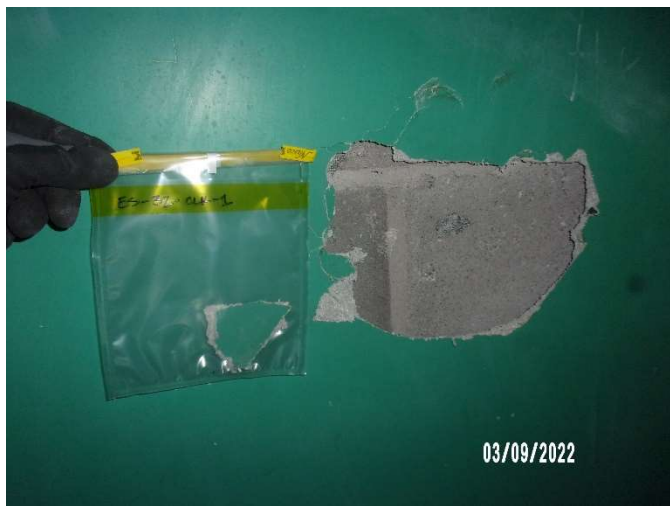
Positive asbestos sample ES-B2-CLK, chalkboard within Building 2.

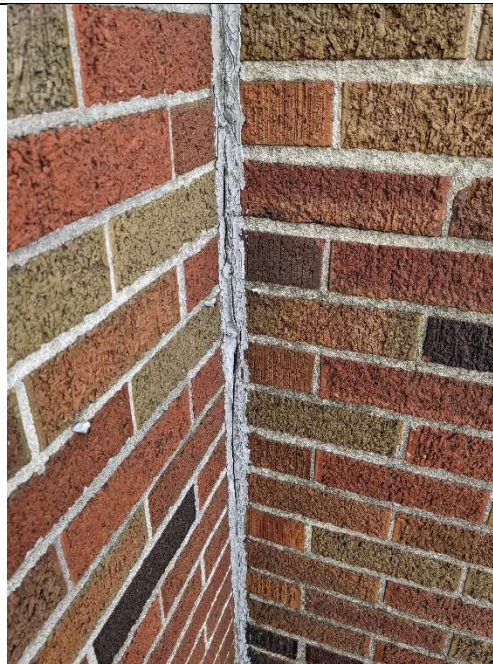
Positive asbestos sample ES-B2-EJ, expansion joint on Building 2.

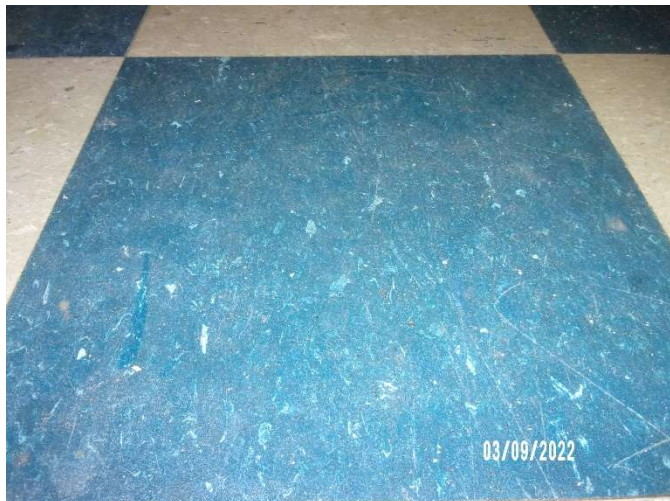
Positive asbestos sample ES-B2-FT1, mastic associated with floor tile shown in Building 2.

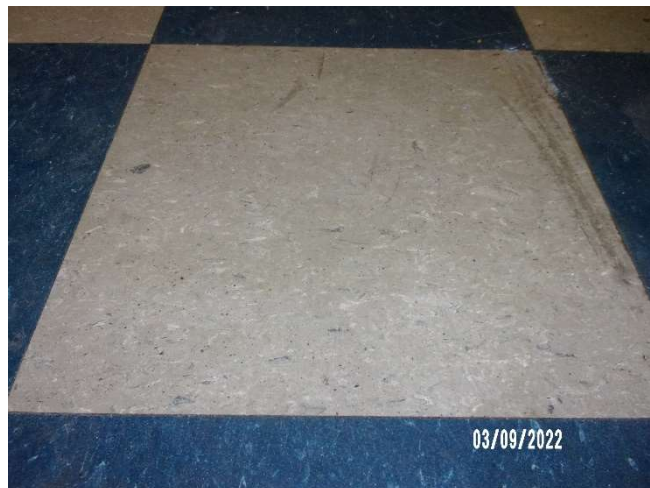
Positive asbestos sample ES-B2-FT2, mastic associated with floor tile shown in Building 2.

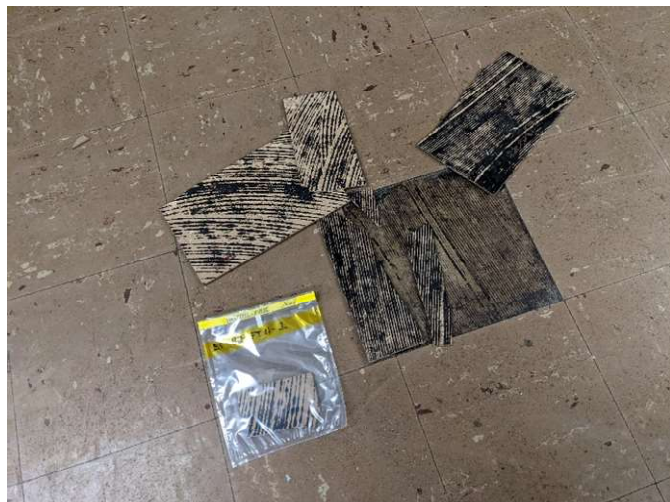
Positive asbestos sample ES-B2-FT4, floor tile and mastic within Building 2.

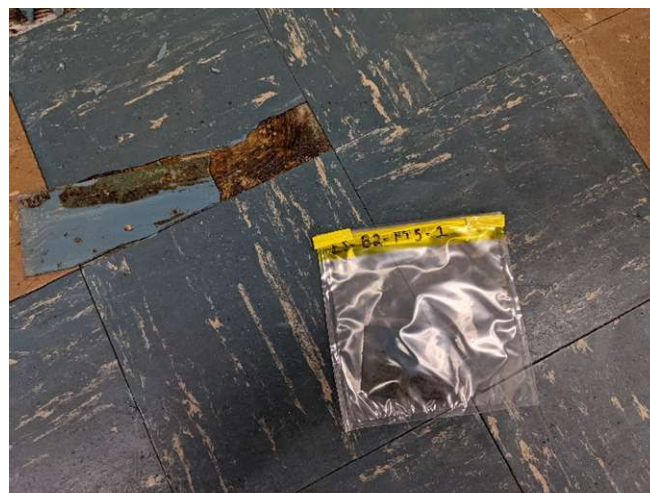
Positive asbestos sample ES-B3-FT5, floor tile within Building 2.

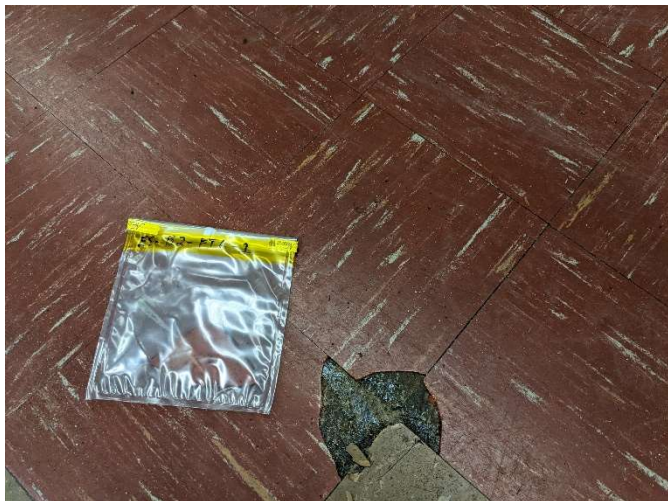
Positive asbestos sample ES-B2-FT6, floor tile and mastic within Building 2.

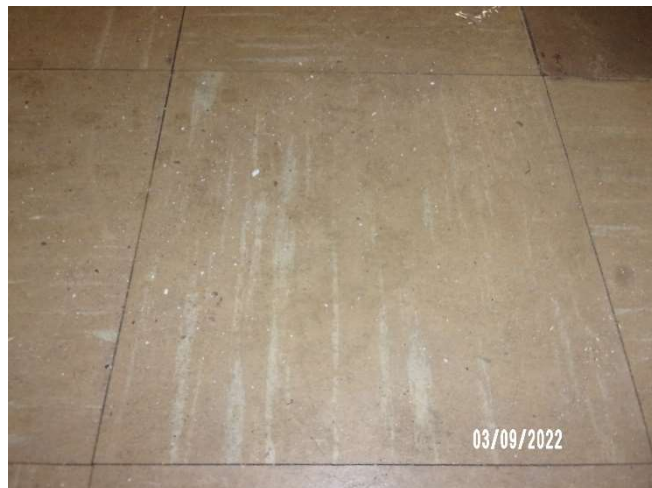
Positive asbestos sample ES-B2-FT8, mastic associated with floor tile shown within Building 2.

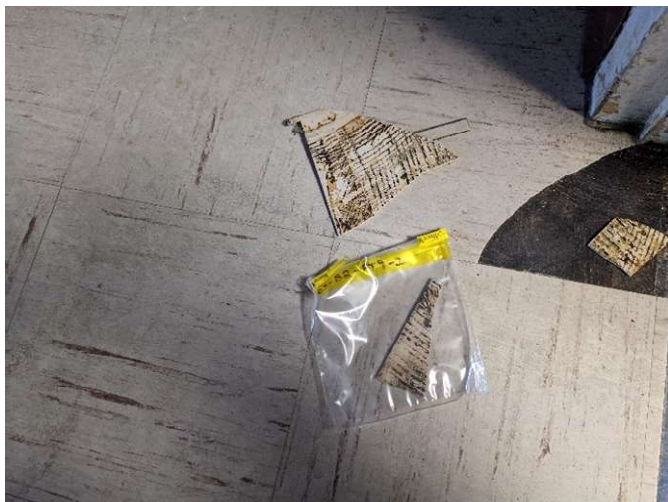
Positive asbestos sample ES-B2-FT9, mastic associated with floor tile shown within Building 2.

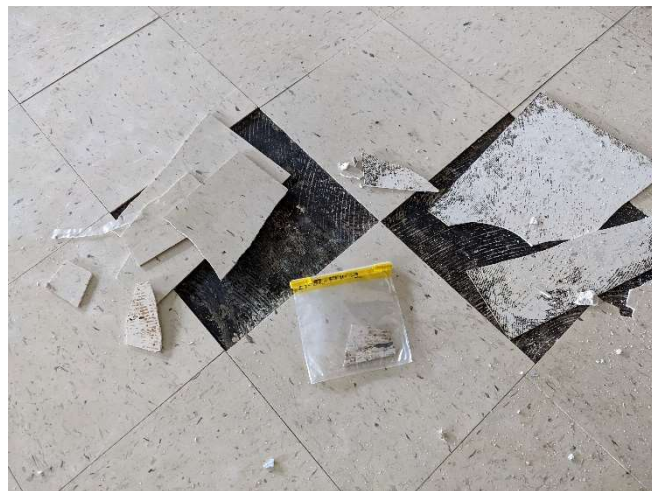
Positive asbestos sample ES-B2-FT10, mastic associated with floor tile shown within Building 2.

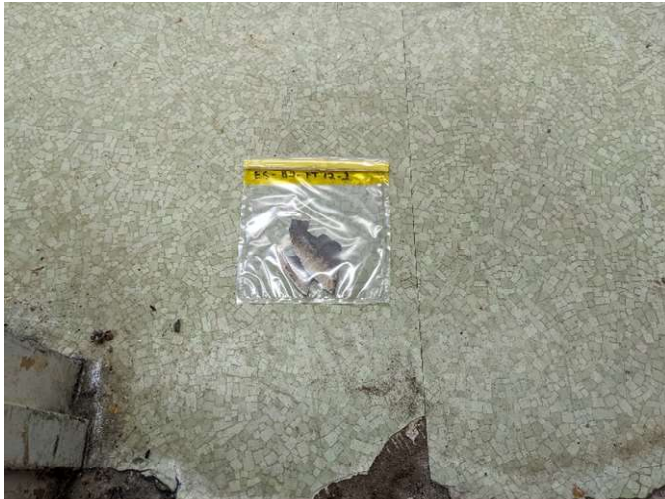
Positive asbestos sample ES-B2-FT12, green linoleum within Building 2.

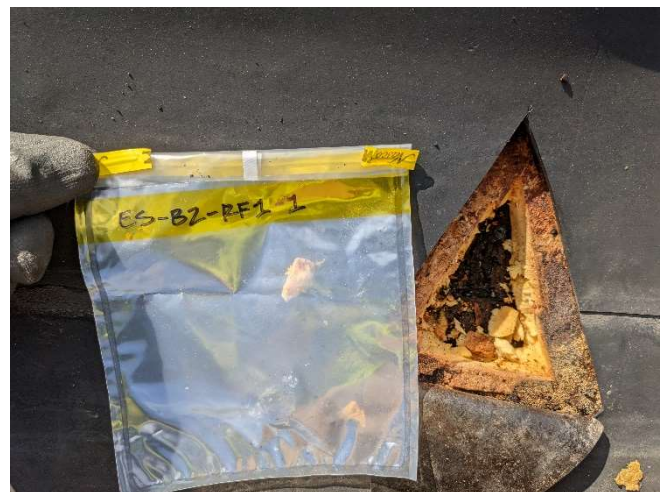
Positive asbestos sample ES-B2-RF1, roofing associated with Building 2.

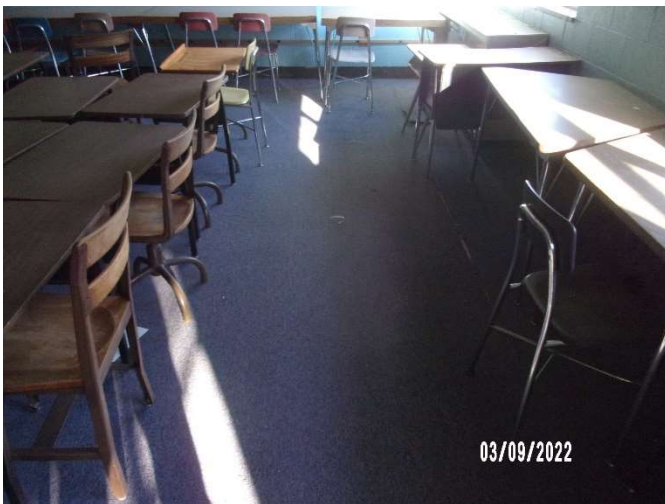
Positive asbestos sample ES-B3-CM1, carpet mastic within Building 3.

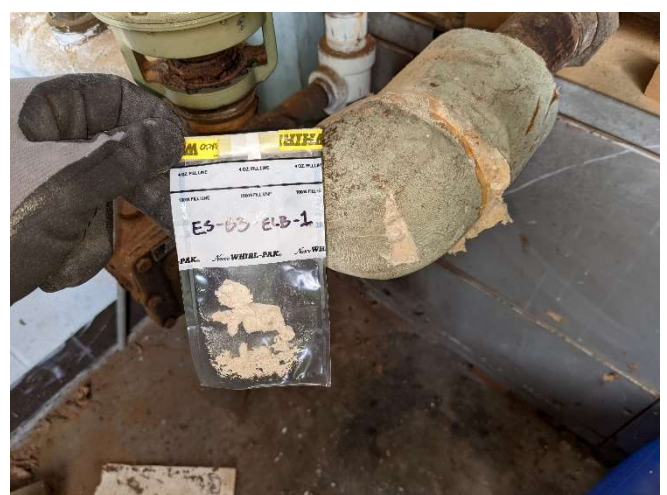
Positive asbestos sample ES-B3-ELB-1, TSI elbow within Building 3.

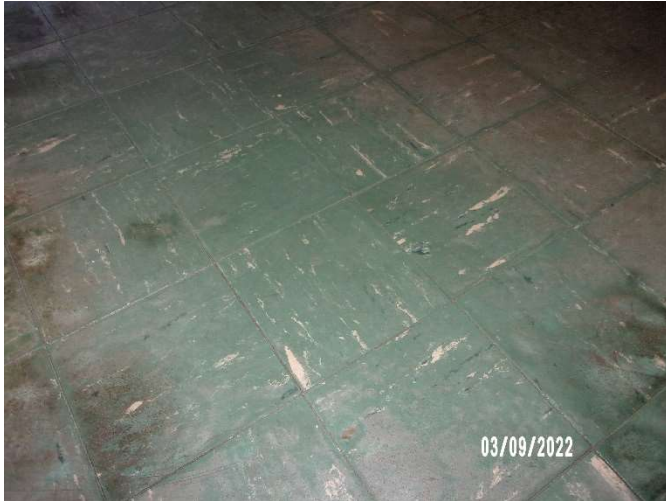
Positive asbestos sample ES-B3-FT1, floor tile and mastic within Building 3.

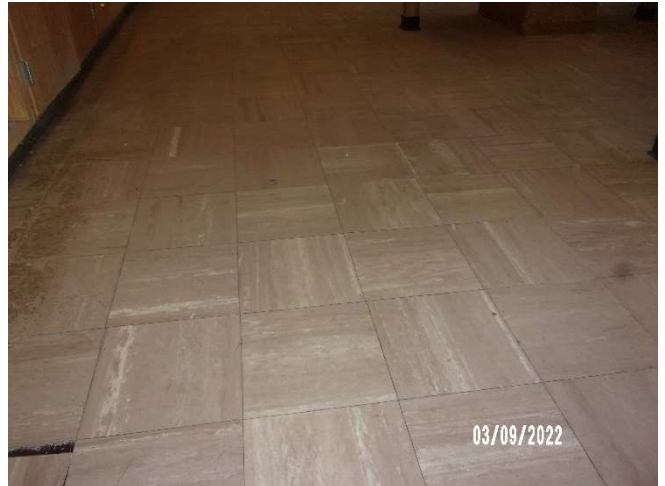
Positive asbestos sample ES-B3-FT2, floor tile and mastic within Building 3.

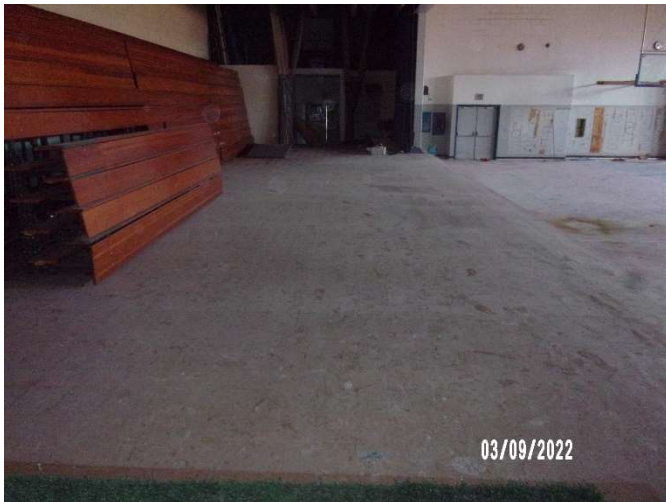
Positive asbestos sample ES-B3-FT3, floor tile and mastic within Building 3.

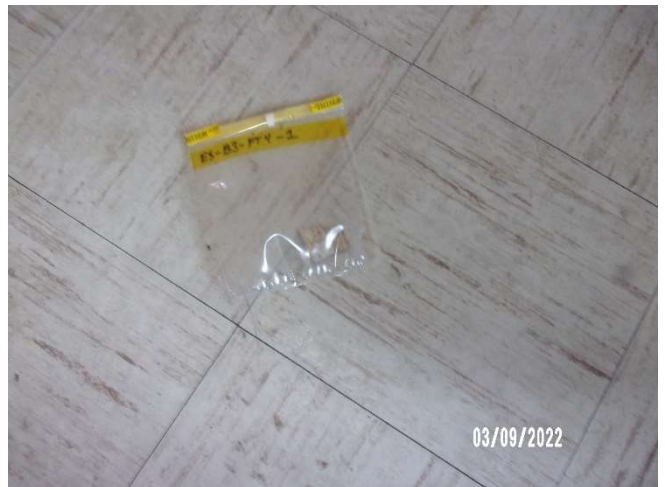
Positive asbestos sample ES-B3-FT4, mastic associated with floor tile shown within Building 3.

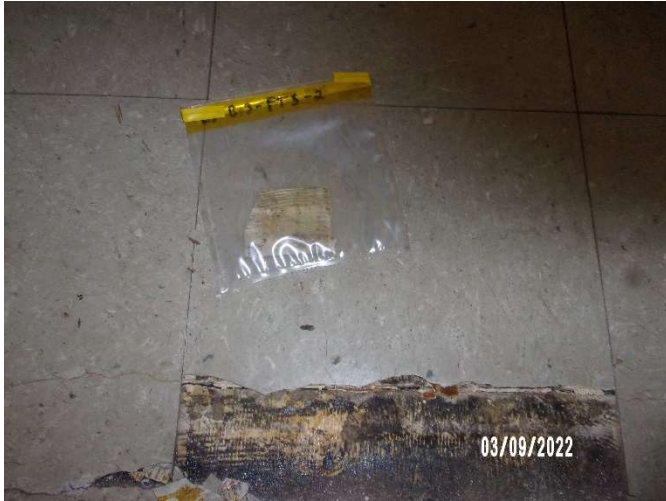
Positive asbestos sample ES-B3-FT5, mastic associated with floor tile shown within Building 3.

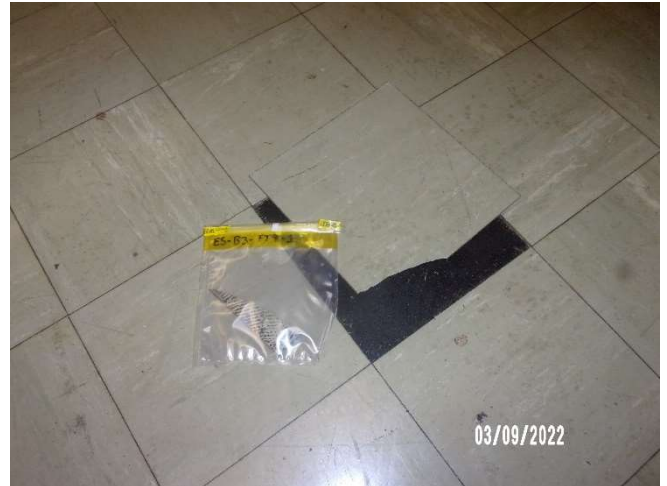
Positive asbestos sample ES-B3-FT9, mastic associated with floor tile shown within Building 3.

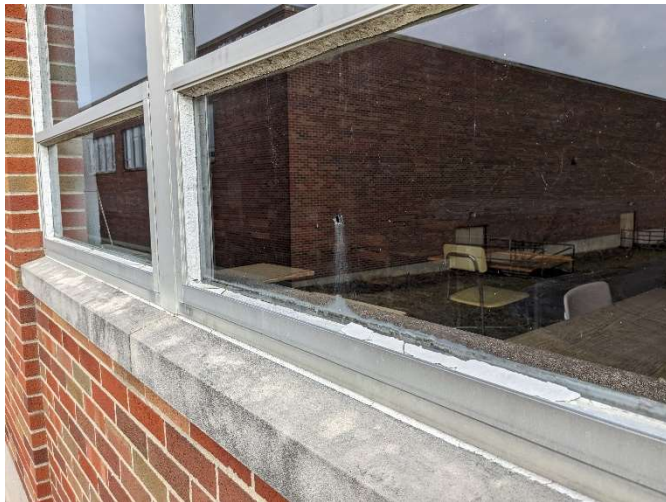
Positive asbestos sample ES-B3-WG, window glazing on Building 3 windows.

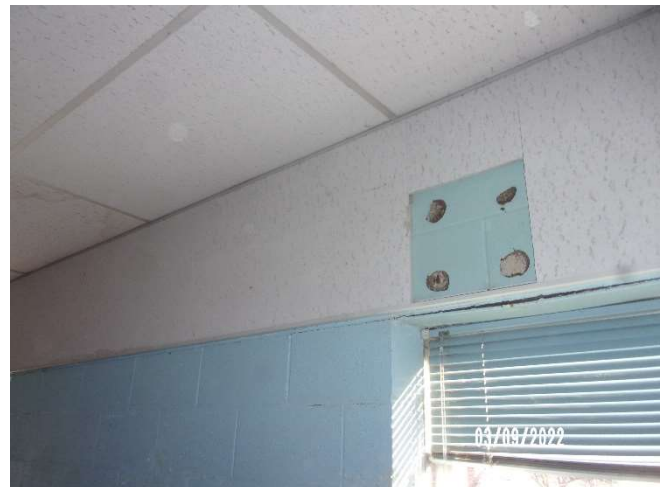
Positive asbestos sample ES-B3-WT1, mastic dots associated with wall tiles within Building 3.

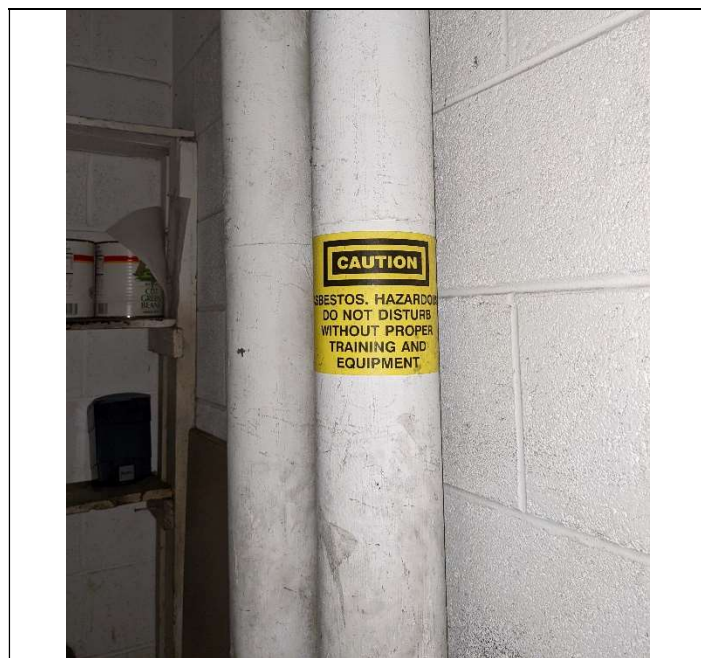
Example of labeled asbestos pipe wrap within Building 2. The TSI was not sampled but assumed to be positive.

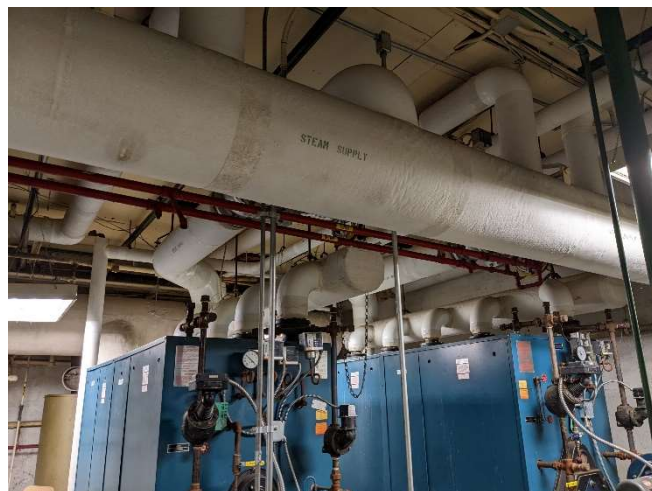
Assumed positive steam supply lines within the boiler room of Building 1.

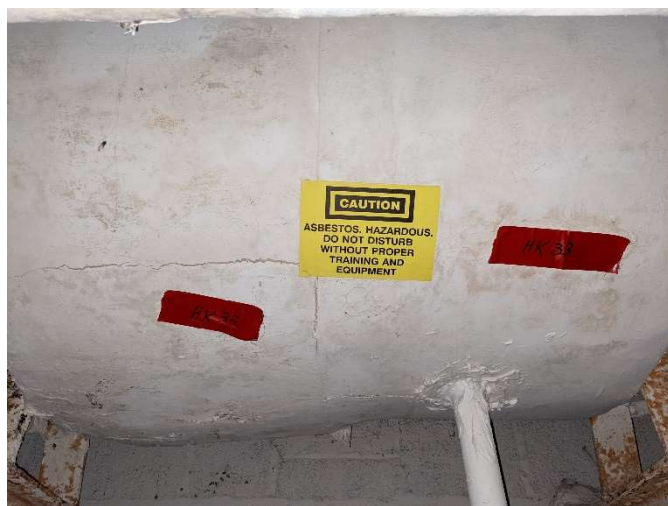
A tank within the boiler room of Building 1 with presumed positive insulation.

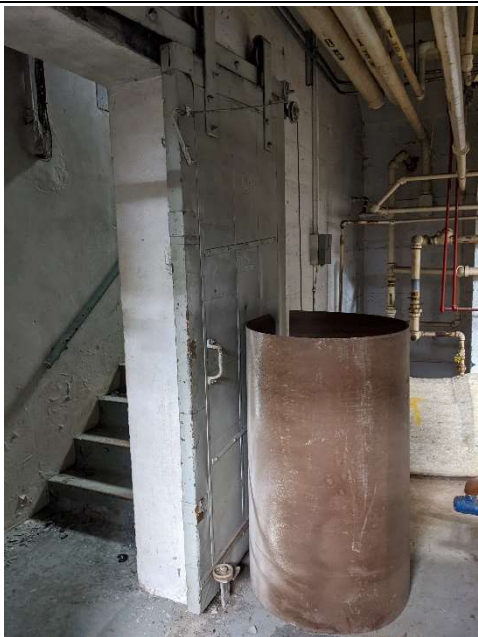
View of a presumed positive fire door within Building 1.
