State of Ohio
Public Works Commission
Application for Financial Assistance

Project Name: Ottawa County Regional Water Distribution - Secondary Feed Loop Zip Code: 43452

Secondary Feed Loop Supporting Documentation

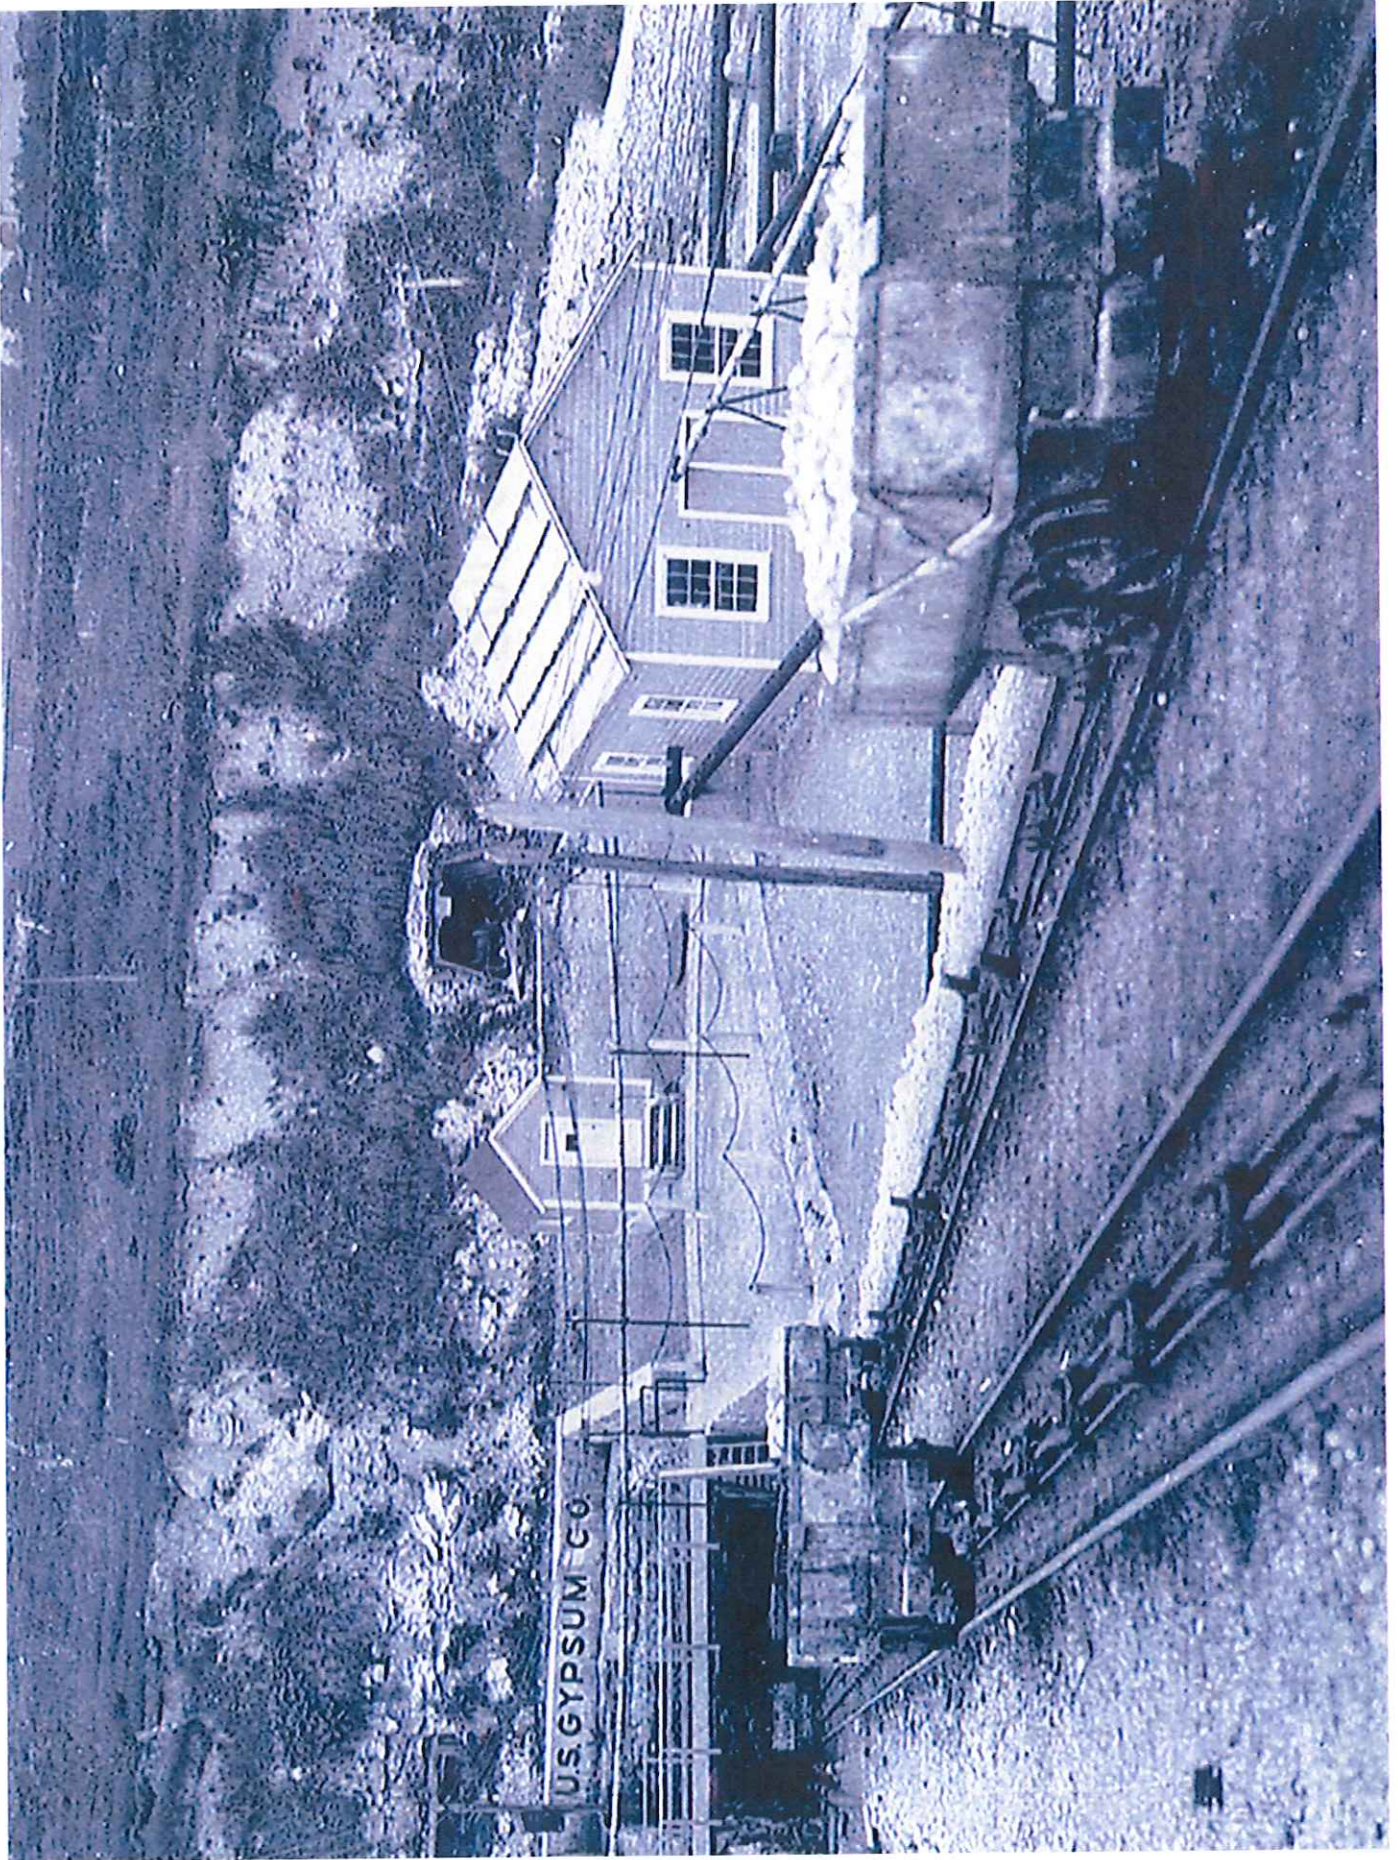
History

- Gypsum mined from 1902 to 1977
- Section under SR-2 mined 1950's – 1960's
- SR-2 constructed in 1965
- Mines flooded in 1979
- Active sinkholes since Dec. 2004

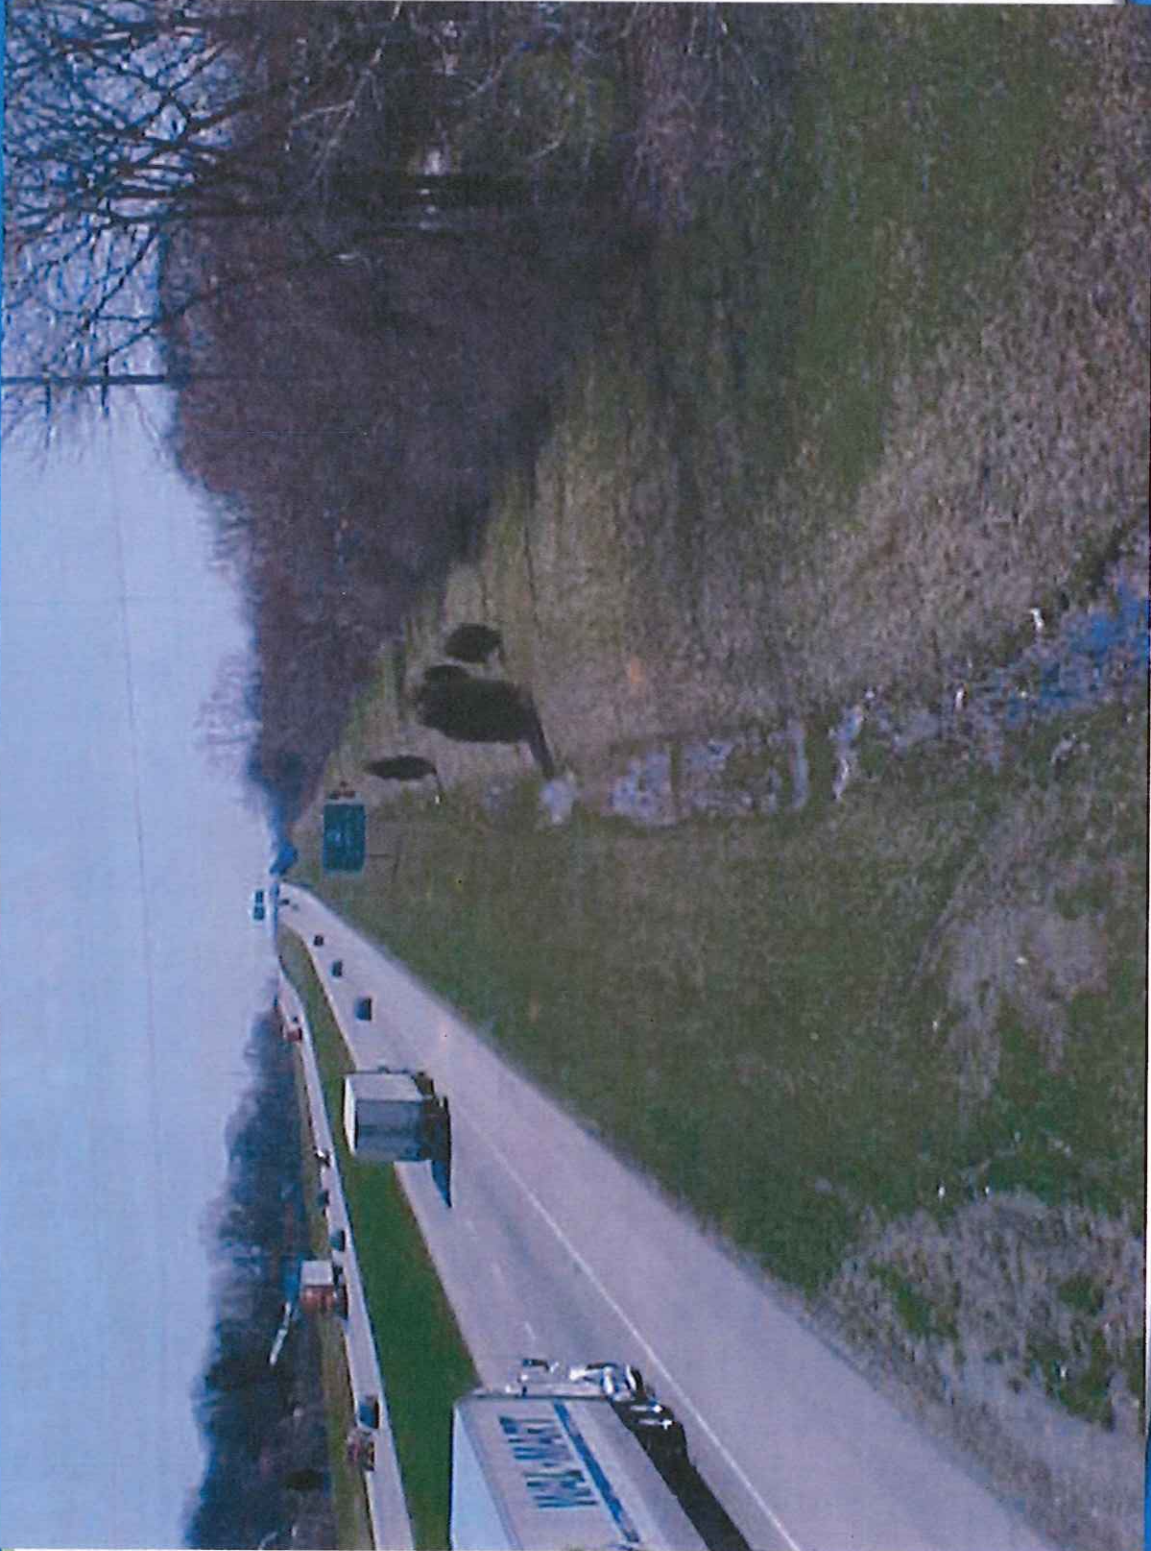
Difficult Mine Conditions

- Lower mine seam covers 500 acres
- Gypsum mine seam 16 feet
- Mine voids average 10 feet, but locally may be up to 15 feet in height
- Deepest section (Ahrens) 85 feet
- Room and pillar, with 15'x15' pillars and rooms span 20 feet
- Overlain by 10-15 feet of dolomite, shale, and gypsum

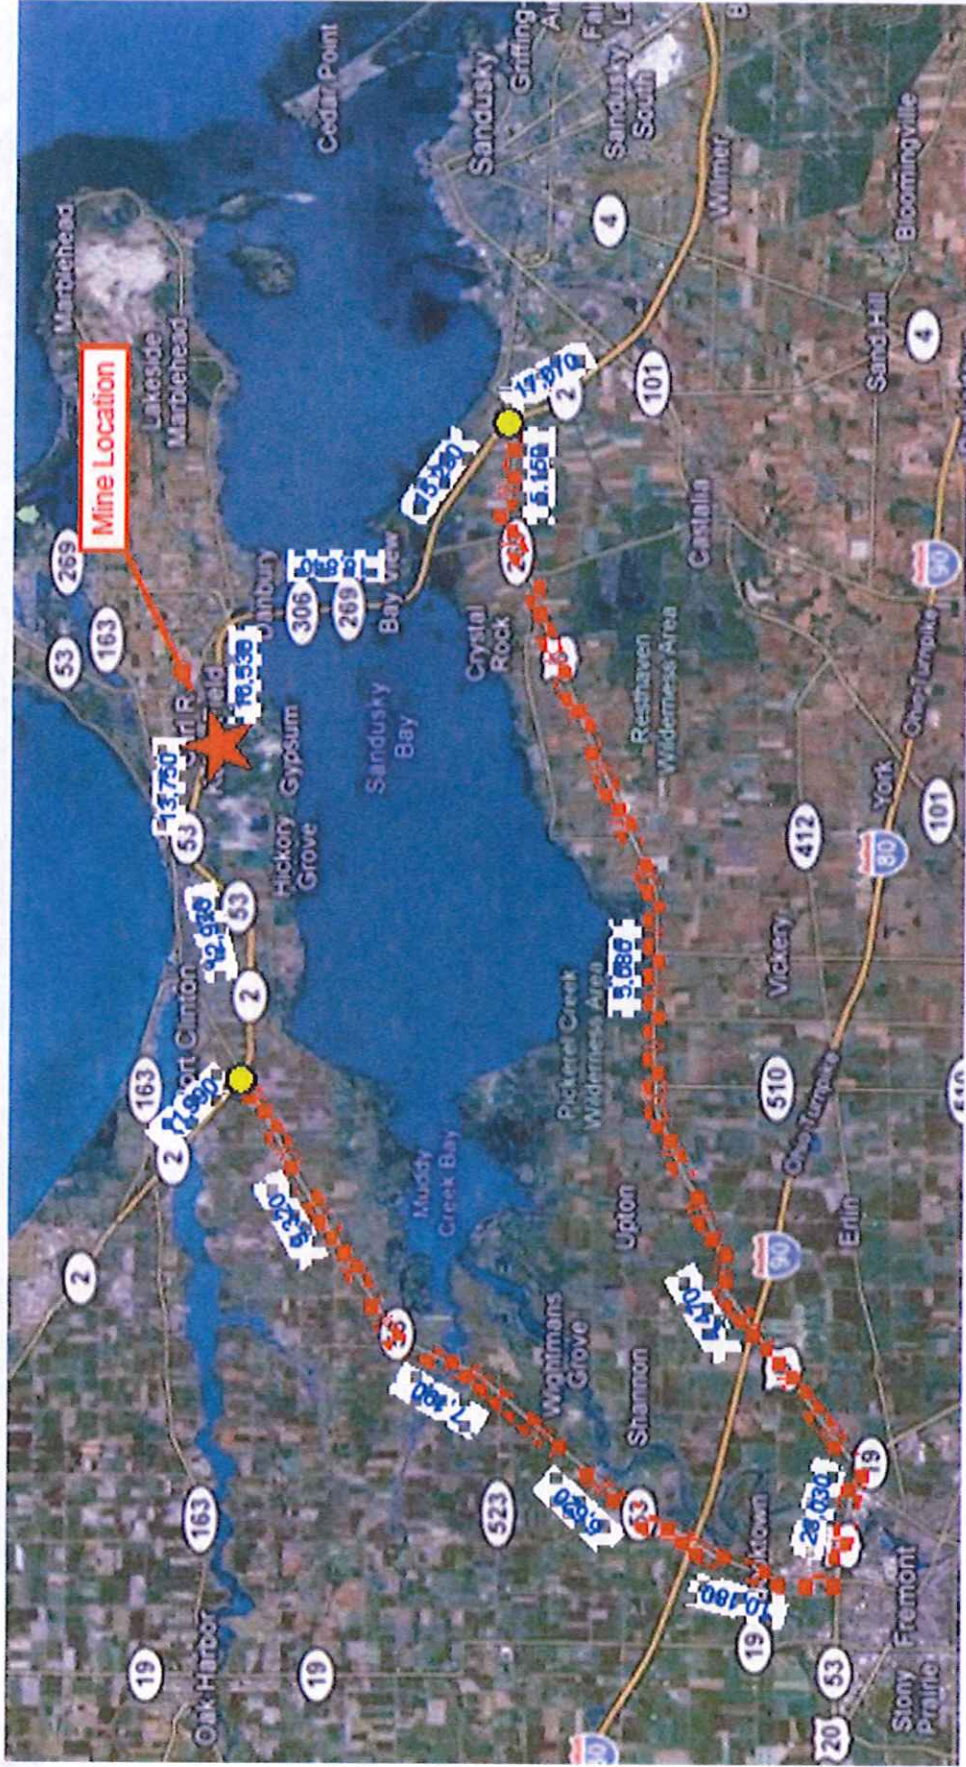
OTT-2 Detour Route and Traffic Volumes

Traffic Counts in Erie (2006), Ottawa (2009) and Sandusky (2009) Counties are from ODOT Traffic Survey Report Detour will add 19 miles to a one-way trip from SR-2/SR-53 interchange to SR-2/US-6 interchange

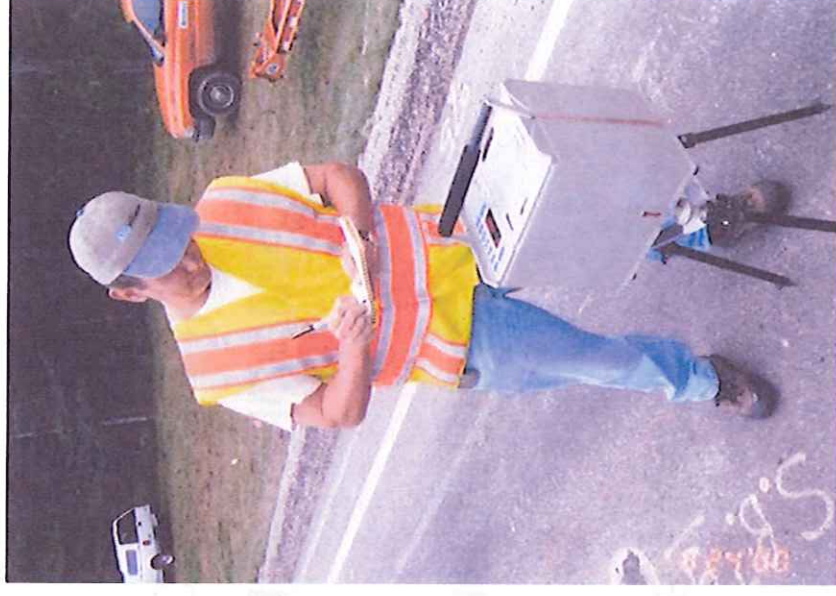
Microgravity

Gravity measurements detect changes in the earth's gravitational field caused by local changes in the density of the soil and rock or engineered structures.

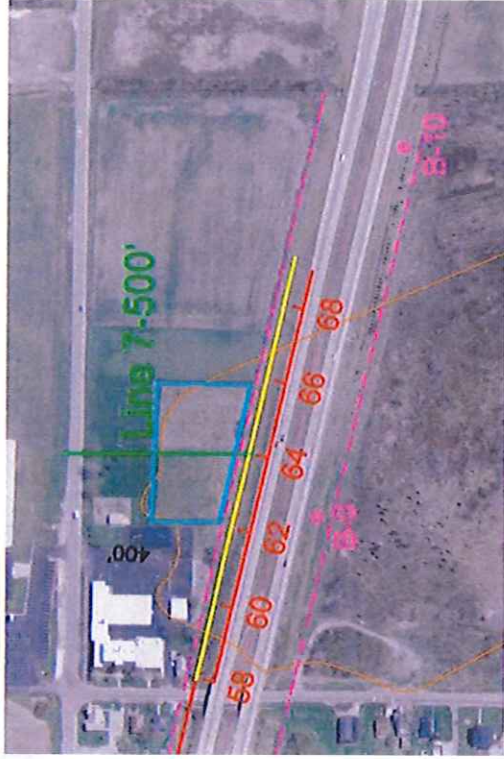
Microgravity Test Data

- Fairly insensitive to depth due to large planar target
- Very sensitive to thickness – 11 ft
- assumes water-filled, could be up to 15 ft or as little as 7 ft, if air-filled

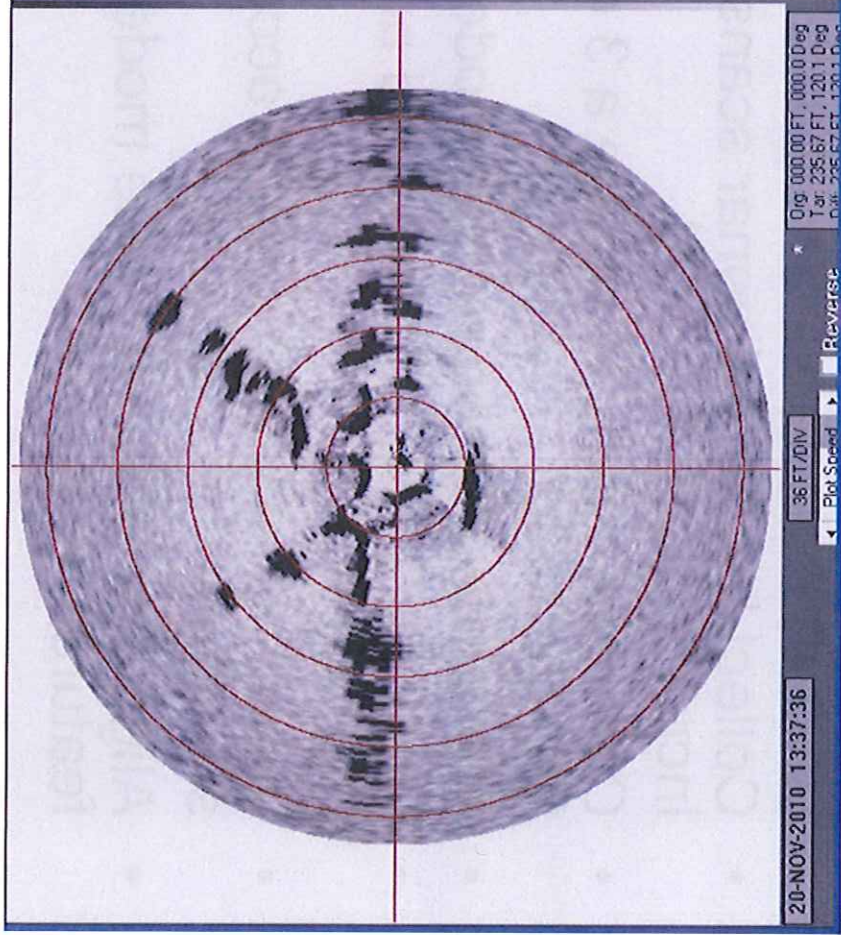
Sonar plot from field P-18

Sonar plot for 1 elevation as viewed in the field

Red circles represent 36 ft per division in this scan

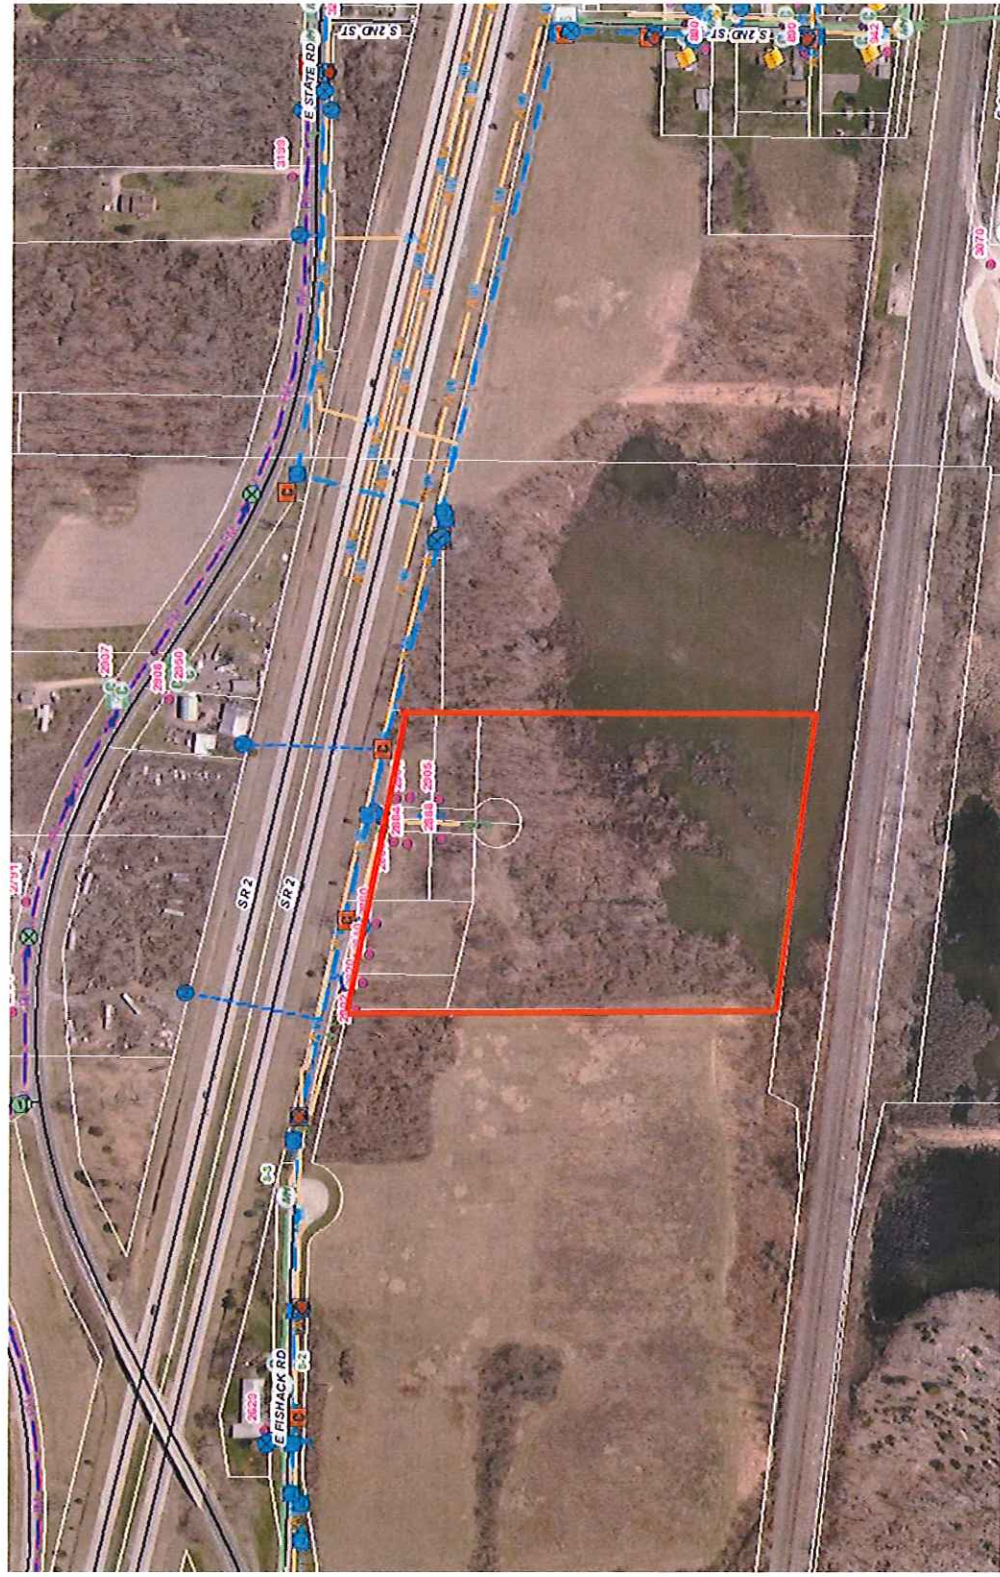
Location of 24" transmission main in relation to Willard Roth properties bought by US Gypsum.
