ASBESTOS ABATEMENT SCOPE OF WORK FOR THE FORMER EDON SCHOOL

309 WEST INDIANA STREET, EDON, OH

December 7, 2022

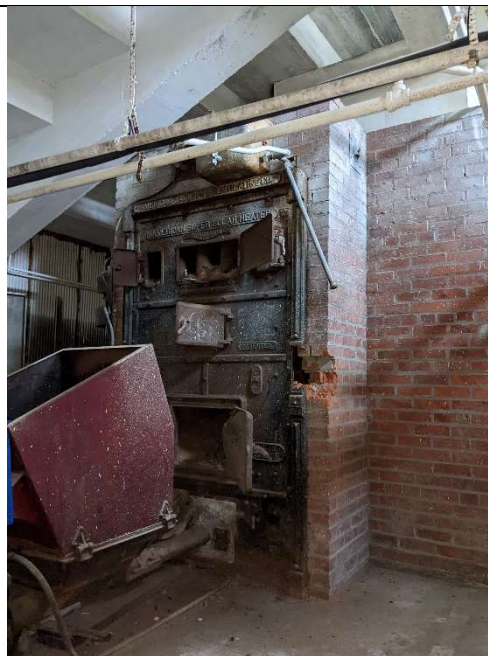
A tank within the boiler room of Building 1 with presumed positive insulation.
